# Understanding Bridge Collapses

**Björn Åkesson**

*Consulting Engineer, Fagersta, Sweden*

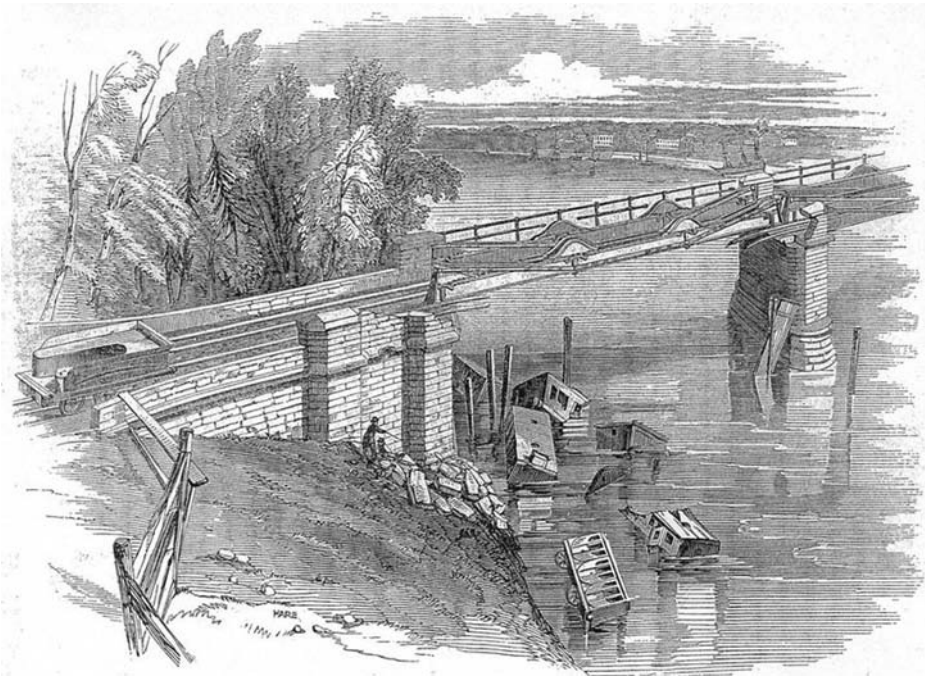
Fig. 1.12 As the train passed the last span over the river Dee, one of the girders failed, and all of the carriages followed the girder into the river below. ([http://en.wikipedia.org/wiki/Dee\\_bridge\\_disaster](http://en.wikipedia.org/wiki/Dee_bridge_disaster))

as a crack had been found in the lower flange of one of the girders. At the repair it was found that the tension bars had not been properly installed, thus making the girder becoming overloaded when trains were passing. However, it was at the same time an apparent proof of the reinforcing effect coming from the tension bars, which saved the bridge from a complete collapse by coming into action after the lower flange of the girder had broke. After repair of this damaged girder, and inspection of the remaining others, the bridge could once again be taken into service. The bridge was thereafter performing without any problems; however, only some six months after the bridge had been taken into service, the bridge collapsed during the passage of a train. The train had left the station in Chester at 6.15 P.M., 24 May 1847 – on its way to Ruabon, approximately 25 kilometres southwest of Chester – and arrived at the Dee Bridge site after just some few minutes. The locomotive and the carriages did pass the two first girder spans without any indication of anything being wrong. However, as the train set was passing the last span, the driver felt the carriages sink beneath him. He pulled full throttle for maximum steam pressure and the locomotive and the tender (the carriage behind the locomotive which carries fuel and water) succeeded to reach the shore behind the abutment, but all the remaining carriages fell into the river. It was the outermost girder – of the two in this last span – that had failed (Fig. 1.12).

Eyewitnesses distinctly talked about a crack that opened up from the lower part of the girder as the bridge span was loaded by the train, and that the last carriage in the train set fell into the river first, followed by the other carriages.

The same morning a 12.5 centimetre thick layer of ballast had been added to the bridge (supported by a wooden deck on top of the sleepers) in purpose of protecting the bridge against any fire hazard (a recent bridge fire – due to hot ashes/sparks – had attracted the attention to this potential risk). This additional loading of about 18 tons on each bridge span was apparently judged as something that the girders could carry, however, it also meant that the mean stress level was increased by some 8–9 MPa, which is a markedly stress raise to an already heavily strained girder. As the fatal train to Ruabon was to pass the bridge later the same day, the total stress loading became too much for the girder to carry, and the tension strength of the same was exceeded.

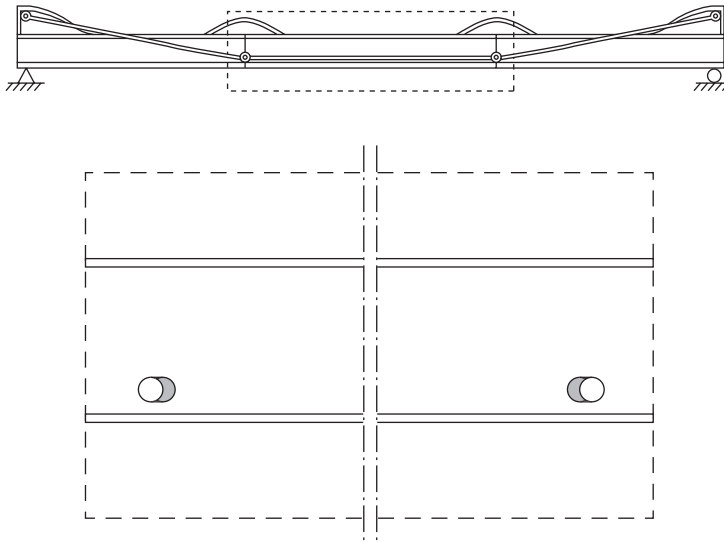
What could instead be a possible cause of failure is a successive *ovalization* of the hole for the pin bolts that join the tension bars together (on either side of the web plate) to the girder. As the girder becomes subjected to bending it will elongate in the lower part, and through this elongation the horizontal tension bars will be forced to interact with the girder (visualized in the figure below for an imagined force  $F$ ) – the tension bars are consequently acting as a constraint against this elongation (read: they unload the girder by supplying extra tension flange area) (Fig. 1.18).

Because of the relative hardness of the tension bars and the pin bolt (in comparison to the softer cast-iron material in the girder, see Fig. 1.9) it will in time develop a localized deformation in the contact pressure area between the pin bolt and the web plate of the girder (the contact pressure here is also the largest). This will lead to an ovalization of the hole (read: remaining plastic deformation) – the hole has quite simply been elongated through wear and excessive local contact pressure (Fig. 1.19).

Fig. 1.20 Elongated holes in the cast-iron girder web plate.

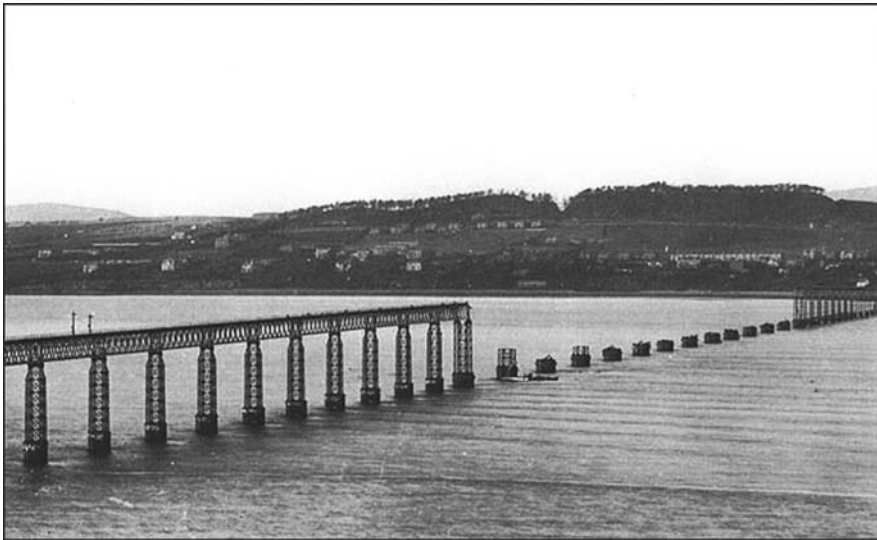
Fig. 3.7 All thirteen high girders of the Tay Bridge had collapsed into the river. (Wolcott: The breaks of progress. Mechanical Engineering)

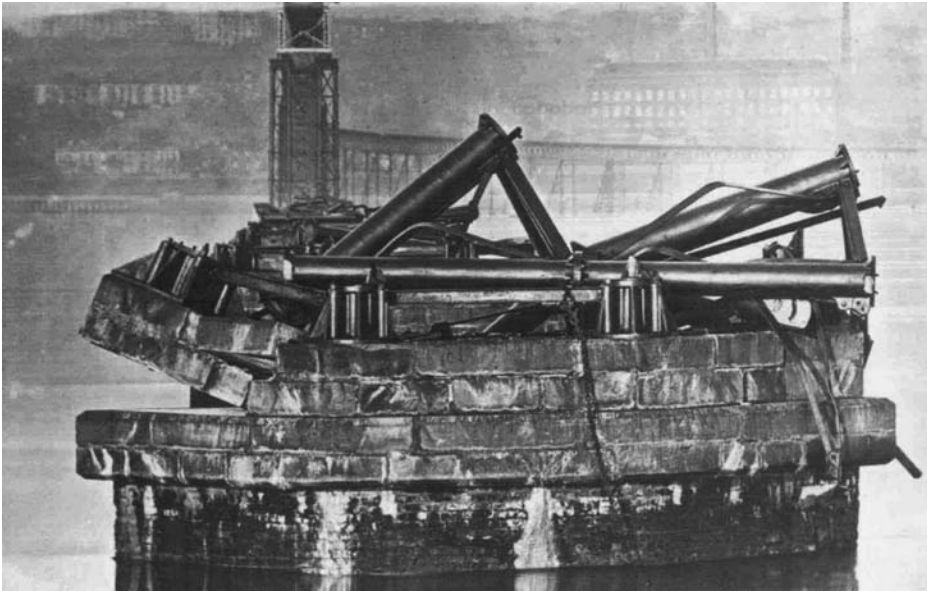
Fig. 3.18 One of the broken piers of the collapsed high-girder bridge section (looking north). (<http://taybridgedisaster.co.uk/>)

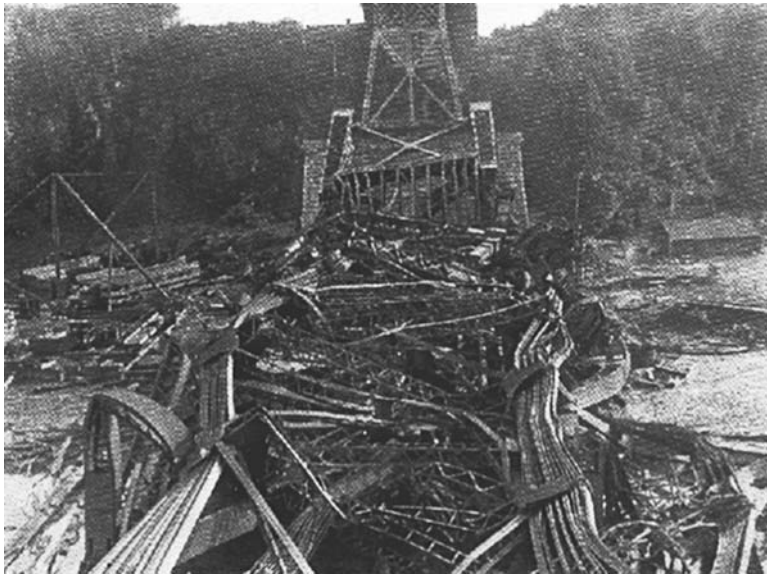
Fig. 4.13 The collapsed 152.5 m long south anchor arm of the Quebec Bridge. The photo is taken from the main pier and facing south towards the river bank. The cantilever arm and the part of the suspended span that was completed lay under water on the river bed. ([www.civeng.carleton.ca/ECL/reports/ECL270/Introduction.html](http://www.civeng.carleton.ca/ECL/reports/ECL270/Introduction.html))

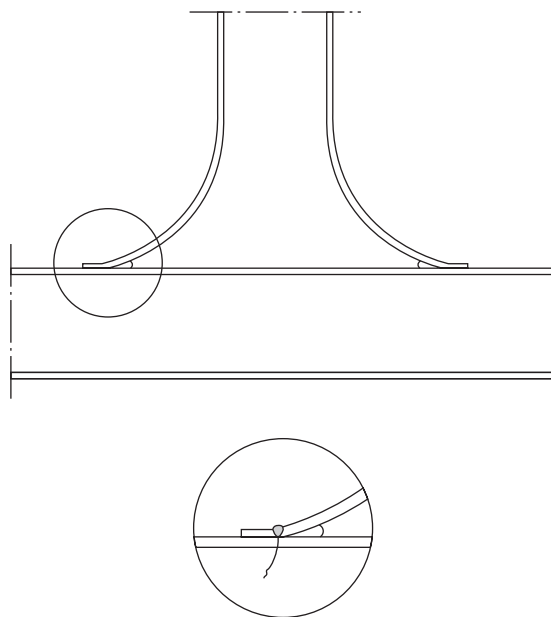
Fig. 5.3 The initiating point where the crack started that ruptured the lower tension chord.

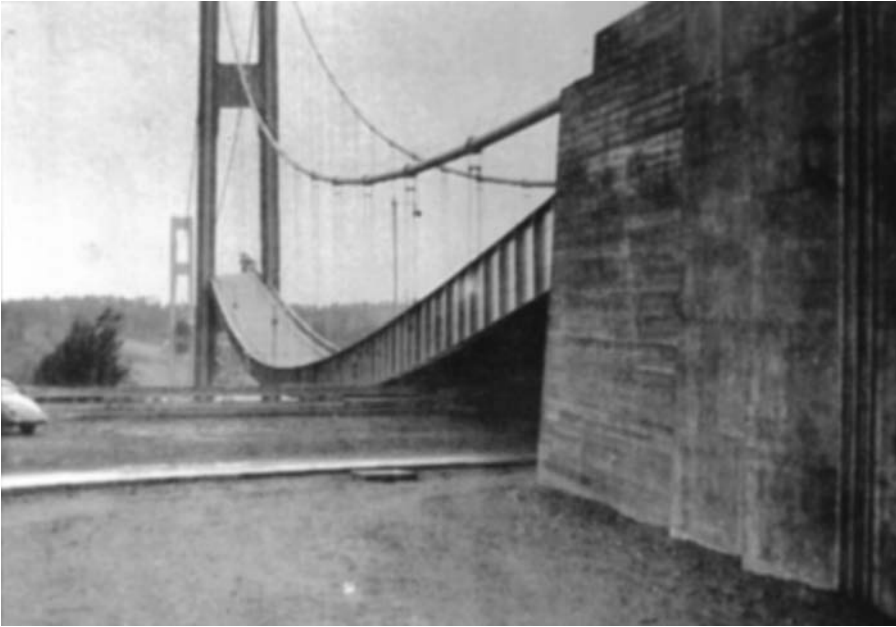
*Fig. 7.7* The deflected side span on the east side, at the time of the collapse of the main span. (University of Washington Libraries, Special Collections, UW 27459z)

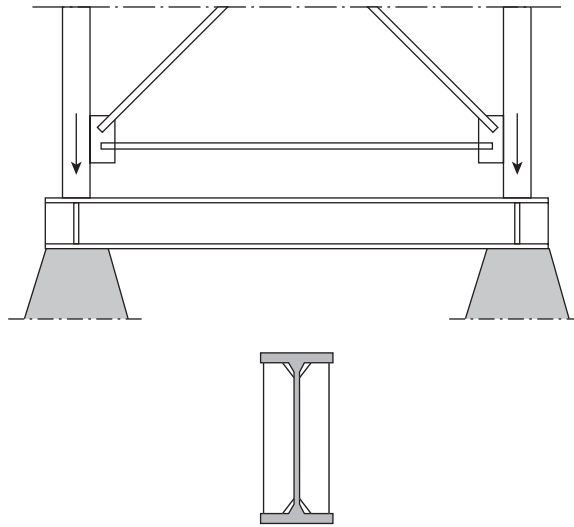
Fig. 9.9 Vertical web stiffeners at the load application points would have saved the bridge, but were unfortunately missing.

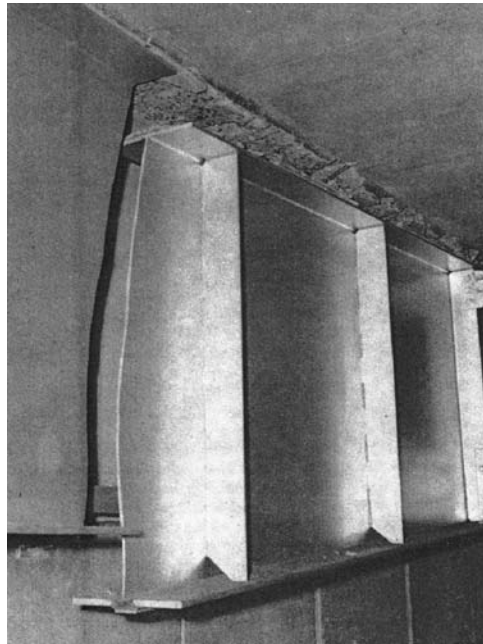
Fig. 10.7 Complete fracture of I-girder No. 1 on the western carriageway. The photo is taken inside the bridge looking north, in between girder No. 1 and 2. (Hopkins: A span of bridges – an illustrated history).

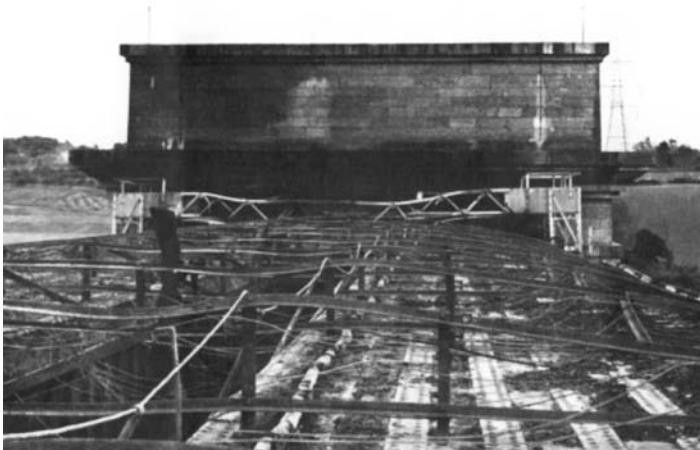
Fig. 13.13 The burnt-down roof of the Britannia Bridge. ([www.2d53.co.uk/britanniabridge/menu.htm](http://www.2d53.co.uk/britanniabridge/menu.htm))

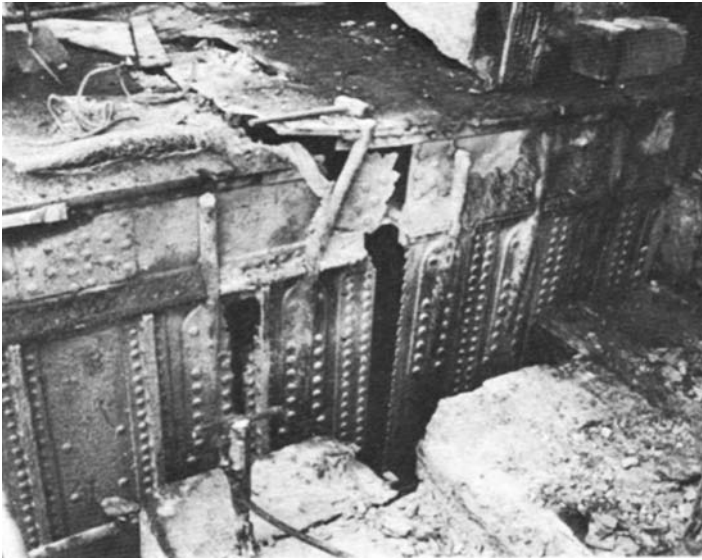
Fig. 13.14 The tubes split open over each intermediate support (i.e. at the towers).

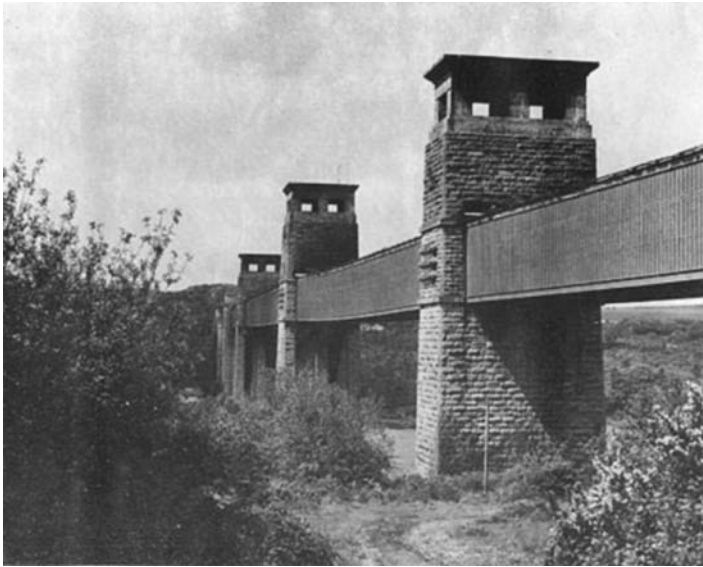
Fig. 13.15 The sagging of the bridge spans because of the vertical split over the intermediate supports. ([http://vivovoco.rsl.ru/MV/E\\_LESSON/BRIDGES/BRIT/BRIT.HTM](http://vivovoco.rsl.ru/MV/E_LESSON/BRIDGES/BRIT/BRIT.HTM))

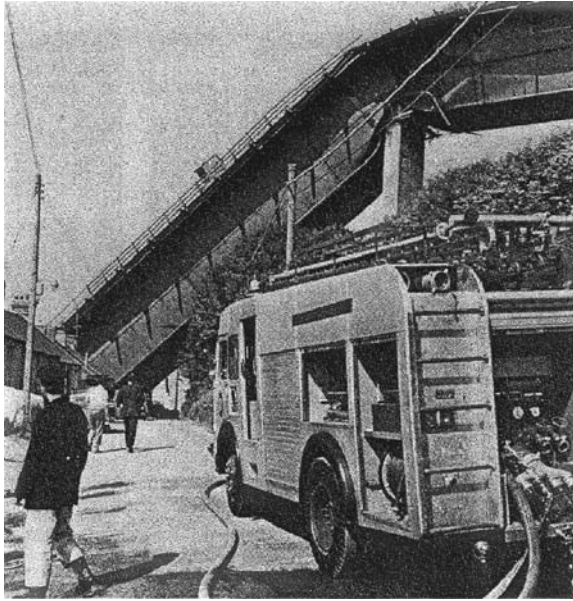
Fig. 14.5 The cantilever arm of the second span on the south end of the bridge buckled over the inner support and fell to the ground. (Aurell/Englöv: Olyckor vid montering av stora lådbroar. Väg- och Vattenbyggaren)

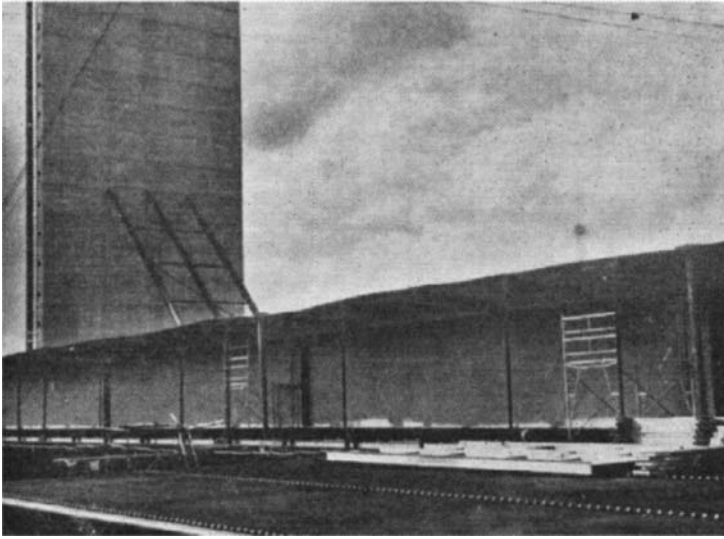
Fig. 15.6 The upper (and outstanding free) flange buckled already when the bridge half lay on the ground, supported at the ends (before being lifted). (Report of Royal Commission into the Failure of West Gate Bridge. Copyright State Government of Victoria, Australia)

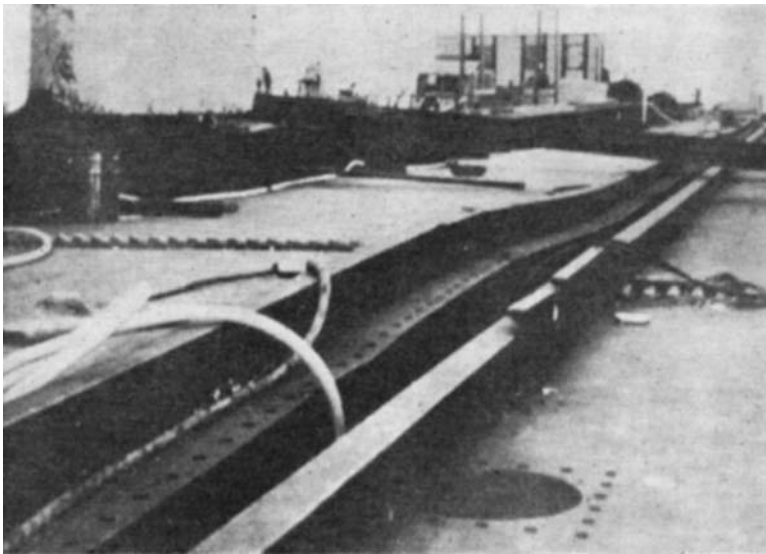
Fig. 15.15 The difference in deflection was evened out by the extra weight of the concrete blocks (to be seen on the left), but the free edge (of the extra loaded half) buckled, still being stiffened by the extra longitudinal stiffener at the free upper flange end. (Report of Royal Commission into the Failure of West Gate Bridge. Copyright State Government of Victoria, Australia)

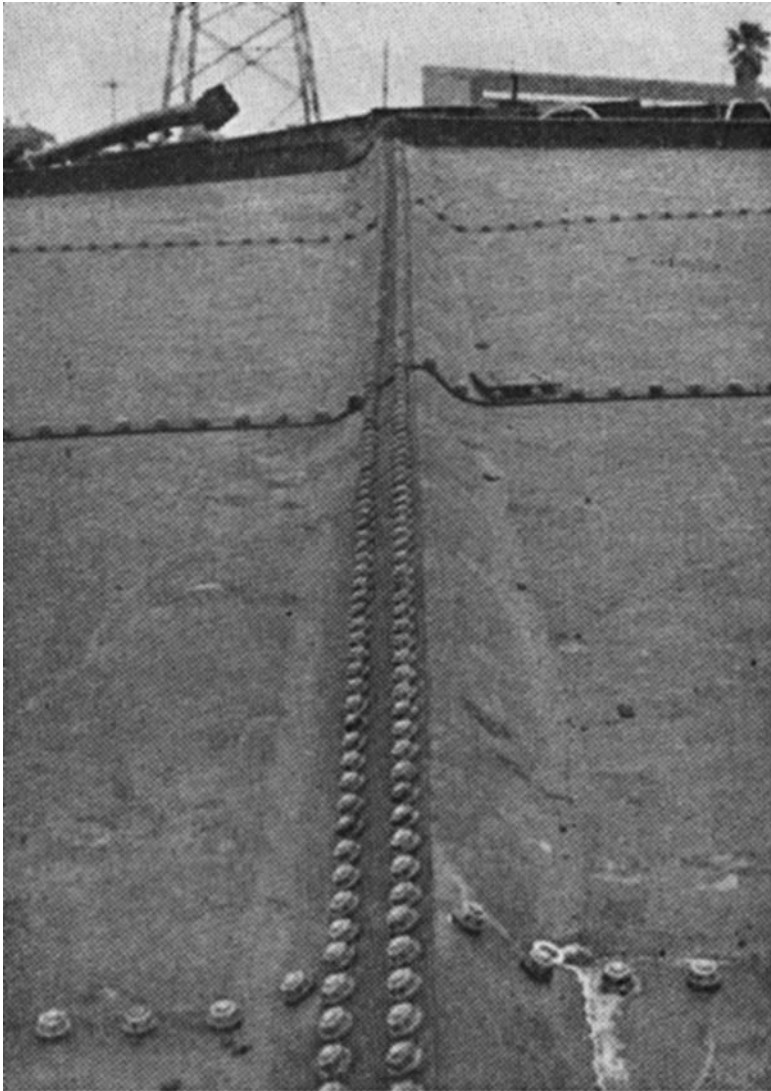
*Fig. 15.19* The local collapse of the deck plate due to the weak splicing of the longitudinal stiffeners (see also Fig. 15.11). (Report of Royal Commission into the Failure of West Gate Bridge. Copyright State Government of Victoria, Australia)

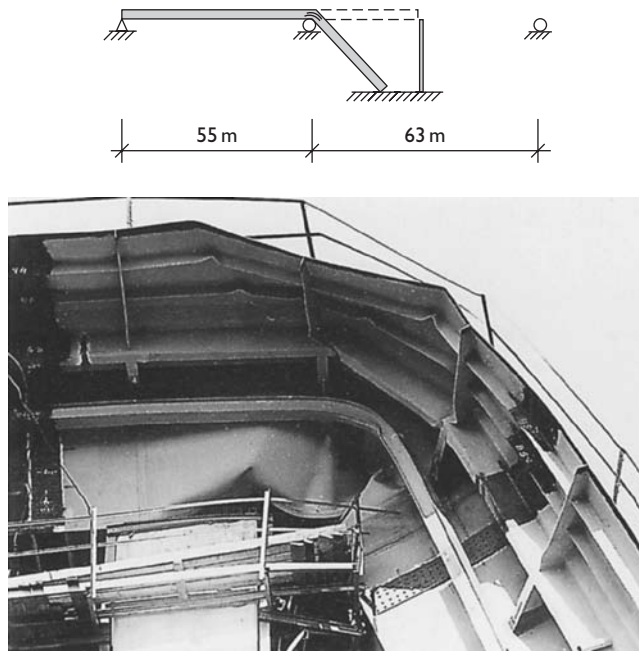
Fig. 17.4 Collapse mechanism and a close-up of the buckled corner (i.e. the hinge). (The photo: Ekardt: Die Stauseebrücke Zeulenroda. Ein Schadensfall und seine Lehren für die Idee der Ingenieurverantwortung. Stahlbau. With kind permission of Karl-Eugen Kurrer)

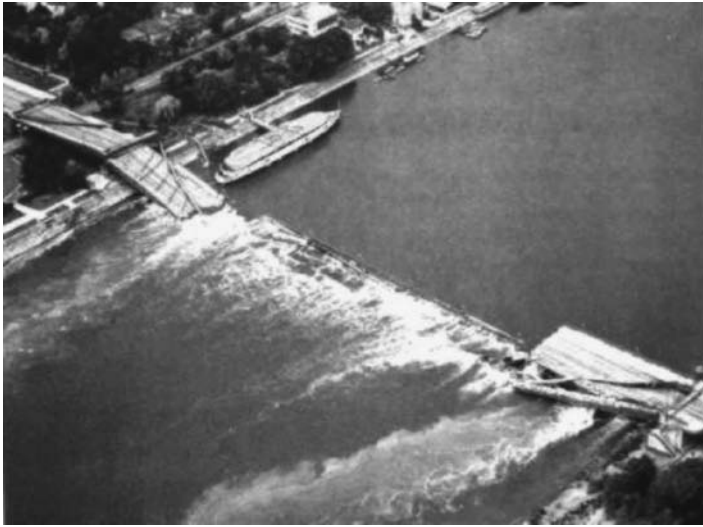
Fig. 18.5 The collapsed Reichsbrücke. ([www.reichsbruecke.net/geschichte\\_e.php](http://www.reichsbruecke.net/geschichte_e.php))

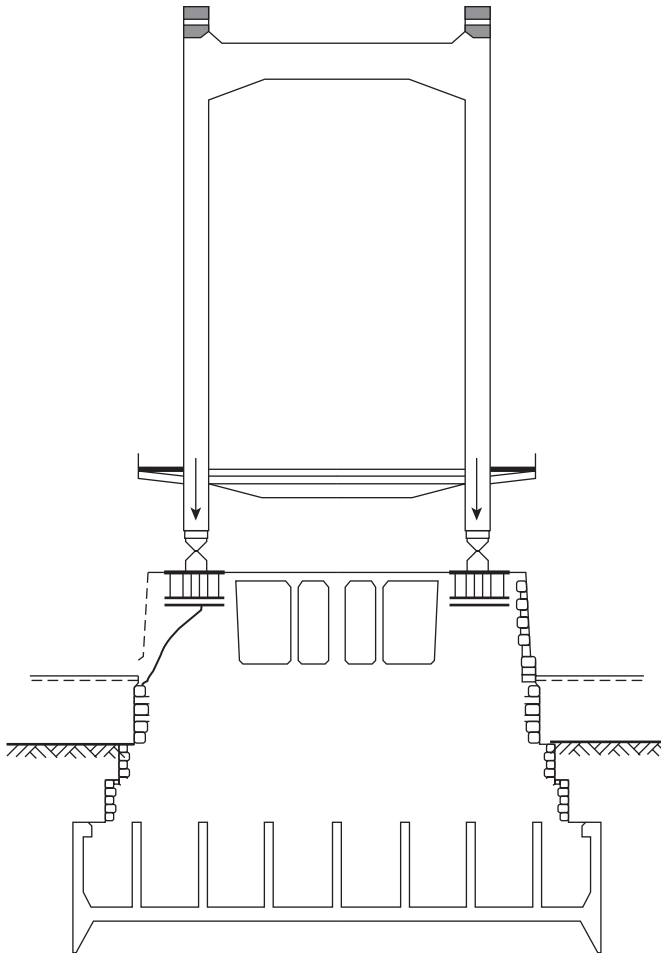
Fig. 18.12 When the tower leg lost its footing the bridge collapsed, tilting to the left. (first published by IABSE in Reiffenstuhl, H.: Collapse of the Viennese Reichsbrücke: Causes and Lessons. IABSE Symposium, Washington 1982)

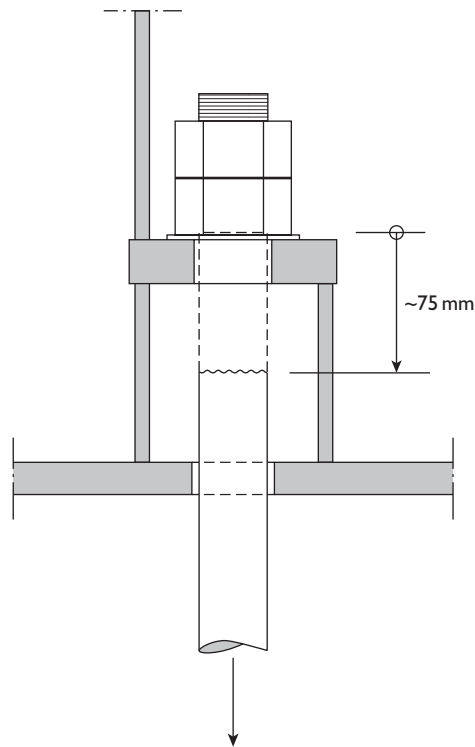
Fig. 20.13 Fracture of Hanger 1 (the one closest to the abutment on the northwest corner of the bridge). See also figure 20.7 as a comparison.

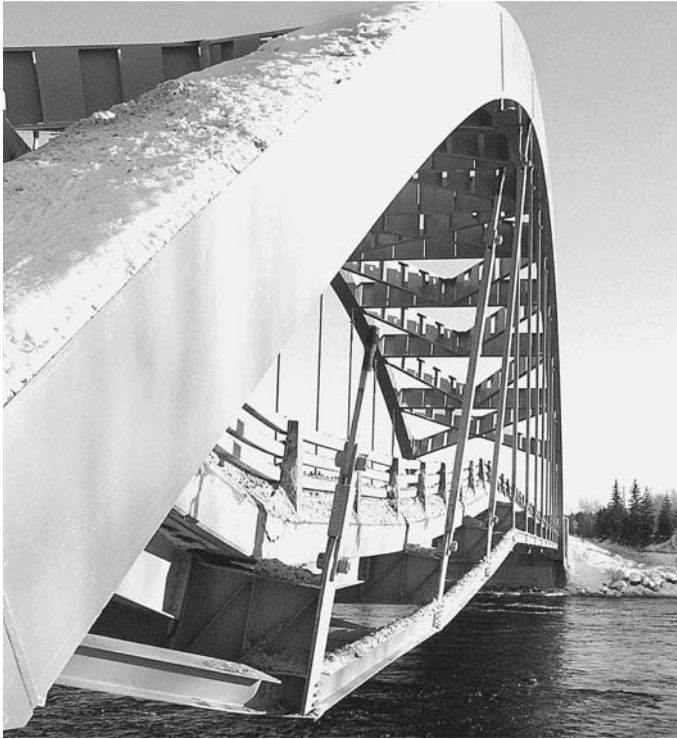
Fig. 20.15 The (partial) collapse of the Sgt. Aubrey Cosens VC Memorial Bridge. (<http://speaker.northernontario.ca/content/Feature%20Story/C%20Front%2011:01:06.pdf>)
