# Understanding Bridge Collapses

**Björn Åkesson**

*Consulting Engineer, Fagersta, Sweden*

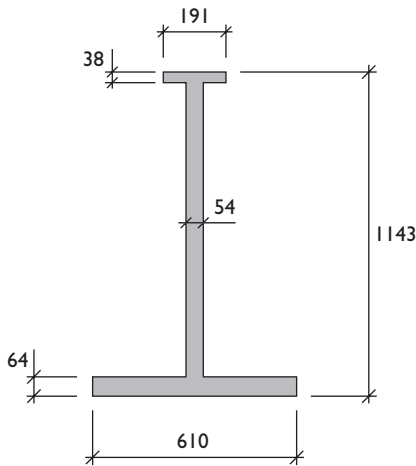
Fig. 1.7 Cross-section dimensions of the mono-symmetrical I-girder. The lower flange was increased in relation to the strength of cast iron in compression relative to the strength in tension, in order to make up for the difference in strength.

Bridge – according to the designers of the time – was consequently a profile where the tension flange area was increased in relation to the compression flange with the inverse proportion (Fig. 1.7, Eq. 1.1).

However, something that was not taken into consideration was the fact that the neutral axis of this mono-symmetrical cross-section does not fall in between the flanges with the same relation (i.e. 3/16 of the girder depth). As the neutral axis of this

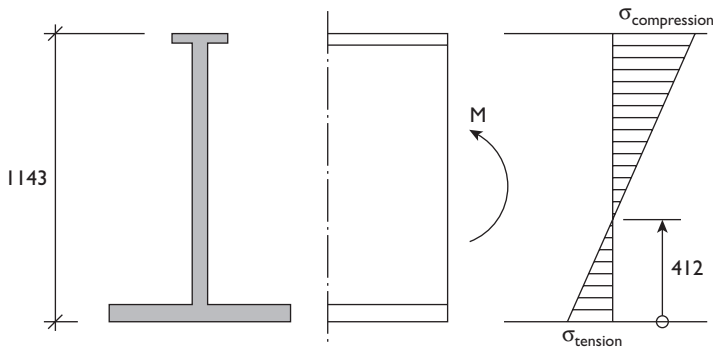
Fig. 1.8 The relationship between the maximum tension stress and the maximum compression stress for pure bending of the unreinforced girder.

cross-section (without tension bars) is found at 412 millimetres up from the lower face of the tension flange, the stress relation becomes altered (Fig. 1.8, Eq. 1.2).

The maximum tension stress at bending will be 56.4% of the maximum compression, instead of the intended relation  $3/16$  (18.75%). Thus the maximum tension stress at bending was very much underestimated, despite having taken the difference in strength into consideration by shaping the I-profile with different flange sizes. However, as the girder – in addition to the mono-symmetrical shaping – also was strengthened by the applied wrought iron tension bars, there is perhaps reason to believe that the load-carrying capacity was heavily enlarged, especially as the wrought iron tension bars have twice as high modulus of elasticity as the cast-iron girder (wrought iron has a modulus of elasticity of about 200,000 MPa, i.e. in the neighbourhood of steel, while cast iron has a value of something like 100,000 MPa) (Fig. 1.9).

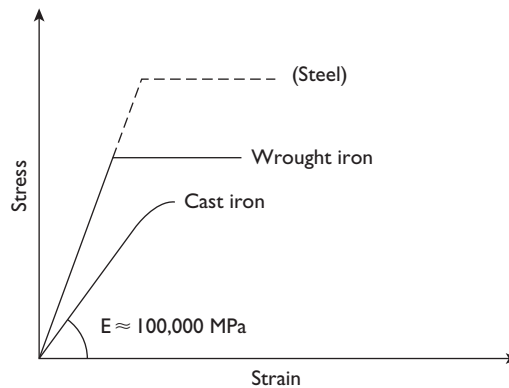
Fig. 1.9 The principal stress/strain-relationship (in tension) for cast iron in comparison to wrought iron (and steel). Cast iron is very brittle, having limited plastic deformation capacity. For one and the same stress level cast iron will deform twice as much as wrought iron.

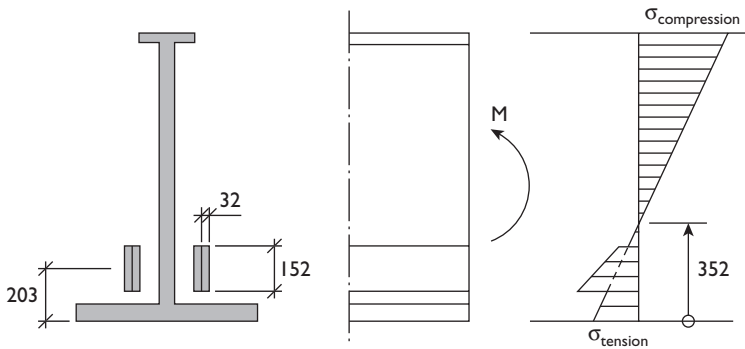
The girder was in the mid-span region part reinforced in the lower part with four wrought iron tension bars – each being  $32 \times 152 \text{ mm}^2$  in size – two on each side of the girder web (with a small free spacing in order to pass the upper flange for the anchorage at the ends). The stress relation is changed in a positive direction due to the fact that the neutral axis is lowered, however, not as much as one perhaps would expect, so the tension stresses are still being underestimated (Fig. 1.10, Eq. 1.3).

With respect to the load-carrying capacity – based on the section modulus for the lower part of the girder subjected to tension – it will increase with approximately 25% for the tension bar reinforced cross-section in comparison to the simple girder. However, as the magnitude of the tension stresses still is being underestimated the load-carrying capacity will still be insufficient. An assumed load test using the design load of that time (a 30 ton heavy and nine metre long locomotive) – three of those positioned close to each other on one of the girder spans – would result in a stress level on the tension side of about 80 MPa, which is on the level of the unreduced strength (read: the strength without any safety factors) for cast iron of *very* high quality. A load test was also performed, however, using less heavy locomotives, and that was lucky,

Fig. 1.10 The relationship between the maximum tension stress and the maximum compression stress for pure bending of the reinforced girder.

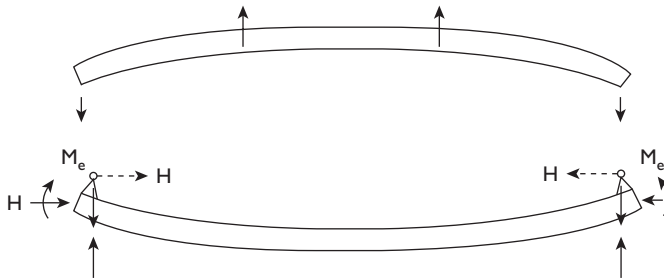
Fig. 1.11 The up-lift and the eccentric attachment at the ends balance each other out.

There is also perhaps reason to believe that a possible pretensioning of the tension bars (e.g. by attaching the bars in a heated condition, and thus introducing a contractive force after cooling), would reduce the tension stresses arising due to the in-service train loading. However, as has been discussed before (with respect to the Queen Post truss and its influence as an integrated system), the “up-lifting” effect will be counterbalanced because of the eccentric anchorage at the ends (Fig. 1.11).

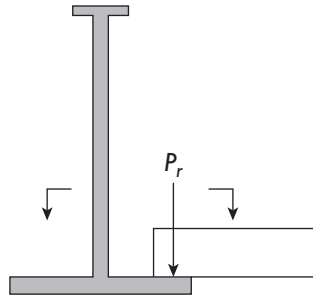
Fig. 1.13 The sleepers introduce an eccentric loading to the lower flange plate.

One of the most recent ideas presented is failure because of *fatigue*, due to the eccentrically applied loading on the lower flange from the sleepers (Fig. 1.13).

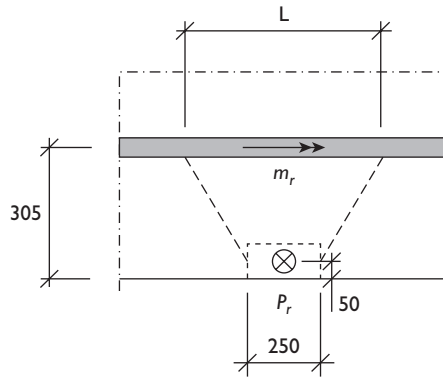
Fig. 1.14 The approximate position on the lower flange of the resulting load from the sleepers.

For a varying load  $P$  (here with an index  $r$  for range), positioned approximately 50 millimetres in from the flange edge, it is possible to determine the local bending moment in the lower part of the girder (Fig. 1.14).

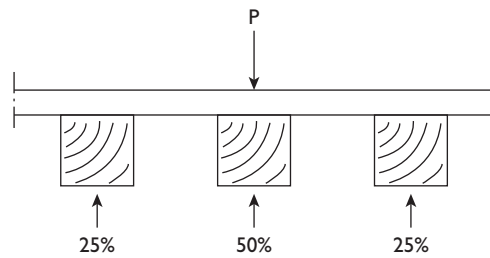
If we consider that the maximum axle loading of that time (being 8–10 tons), we are able to calculate the cyclic load (read: the load range). We must also take into consideration the load distribution effect in the longitudinal direction coming from the rail (Fig. 1.15, Eq. 1.4).

Fig. 1.15 The load distribution among adjacent sleepers.

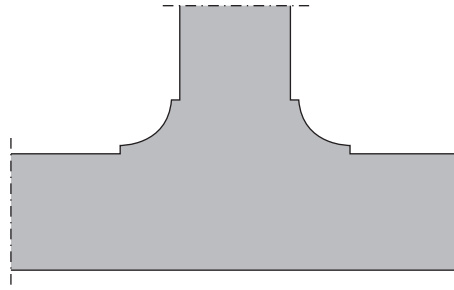
The suggested fracture scenario was that an initiated fatigue crack, in the transition area between the flange and the web in the lower part of the girder, gradually would have propagated to a certain critical length (with respect to brittle fracture) and thus caused the sudden collapse. However, we can see from the calculations above that the *maximum* stress range not the least is of such magnitude that the fatigue limit for cast iron would be exceeded, and this is still the fact despite that cast iron is having blisters and other impurities, which makes it weaker (and more brittle) than modern steel of today. There is also an additional stress raising factor to consider in the affected area, and that is the especially designed fillet transition between the flange and the web (Fig. 1.16).

Fig. 1.16 The fillet transition between the flange and the web acts as a stress raiser as this area is not smooth.

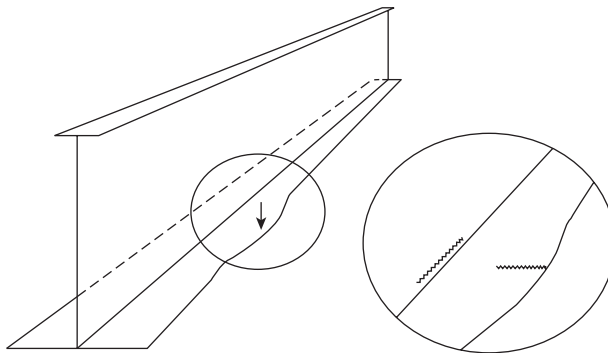
Fig. 1.17 Possible fatigue cracking locations due to local bending of the flange plate.

This decorative shaping is raising the local stress level, but not as much as for a similar welded detail (in steel), which have a fatigue limit that exceeds the stress range level calculated here. We must also not forget that the calculated stress range is for an assumed *maximum* axle weight, which is rather unlikely to occur, at least with regard to any large number of cycles. During the six months the bridge was in service the local stress reversals produced were not of any significant magnitude, and those stress cycles that did occur were still having a fairly low number of repetitions (due to the limited period of time together with the relatively low number of train passages per day). Consequently we could rule out the possibility of any fatigue cracking to occur. And if we – despite the fact that no fatigue cracking could have taken place – still imagine us a crack in the upper part of the fillet being initiated, then this crack would be *horizontal*, i.e. parallel to the normal stress direction due to the global bending of the girder. Such a surface crack – horizontal and single sided (i.e. not going through the thickness of the web plate) – does not constitute a direct threat to a possible brittle fracture risk, which transverse cracks do. For local bending of the flange there is, in a way, also a possible risk for a transverse crack to be initiated, however, the bending stresses here are much lower than those that arise in the web-to-flange transition, so for the case of the Dee Bridge a transverse crack is even less probable than a horizontal (Fig. 1.17).

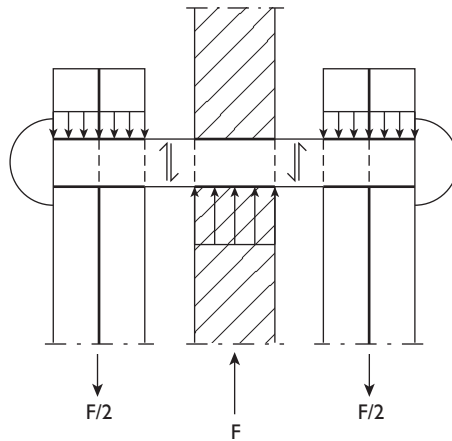
Fig. 1.18 Through shear in the pin bolts the elongation of the lower part of the girder (when subjected to bending) is restrained by the wrought iron tension bars.

What could instead be a possible cause of failure is a successive *ovalization* of the hole for the pin bolts that join the tension bars together (on either side of the web plate) to the girder. As the girder becomes subjected to bending it will elongate in the lower part, and through this elongation the horizontal tension bars will be forced to interact with the girder (visualized in the figure below for an imagined force  $F$ ) – the tension bars are consequently acting as a constraint against this elongation (read: they unload the girder by supplying extra tension flange area) (Fig. 1.18).

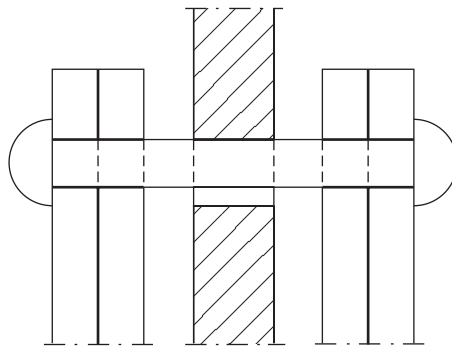
Fig. 1.19 Due to the repeated loading the bolt hole in the girder web becomes over time elongated (ovalized).

Because of the relative hardness of the tension bars and the pin bolt (in comparison to the softer cast-iron material in the girder, see Fig. 1.9) it will in time develop a localized deformation in the contact pressure area between the pin bolt and the web plate of the girder (the contact pressure here is also the largest). This will lead to an ovalization of the hole (read: remaining plastic deformation) – the hole has quite simply been elongated through wear and excessive local contact pressure (Fig. 1.19).

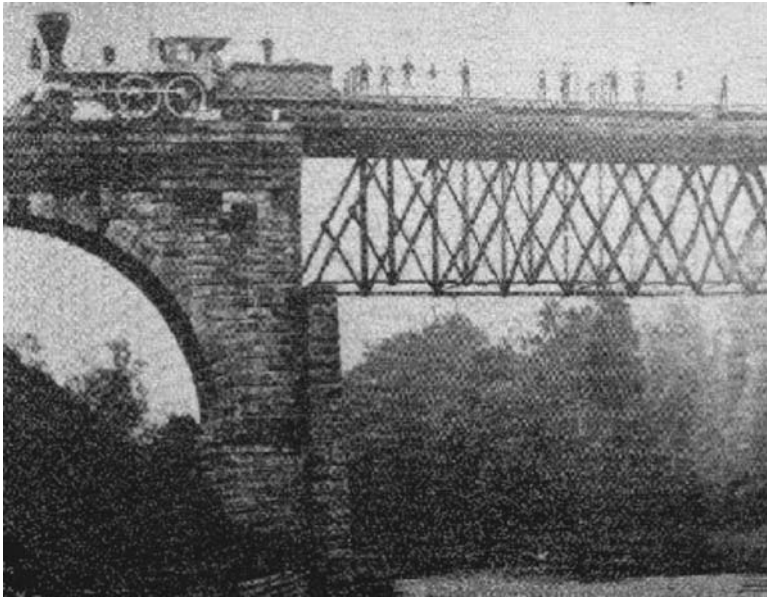
Fig. 2.2 The Ashtabula Bridge some years before the collapse. ([www.prairieghosts.com/rr\\_disaster.html](http://www.prairieghosts.com/rr_disaster.html))

in the north-eastern corner of the State of Ohio. The visibility was more or less non-existent as the train slowed down in order to pass over the Ashtabula River Bridge, just before reaching the station. As the leading locomotive was almost at the end of the bridge, the driver heard a cracking coming from the bridge and he suddenly felt that he was driving “up-hill”. As he immediately understood that the bridge was to give way, he pulled the throttle for maximum steam pressure – just as the driver did in the Dee Bridge collapse (see Chapter 1). The acceleration force forward, and the pulling force backwards from the second engine and the cars on the bridge span, made the coupling-device between the two locomotives break. The front locomotive managed to reach the west abutment on the river-bank, and the driver could in his despair and horror see how the cars on the bridge, as well as the cars still behind the abutment on the east river-bank were pulled down in to the river below. The collapse was in itself a slow and prolonged process, as the train functioned more or less like a linked chain load, which gave a certain resistance to the bridge failure. The photo above of a working train on the Ashtabula Bridge (taken some years before the collapse) does show the approximate position of the front engine as the cars behind went down with the bridge (Fig. 2.2).

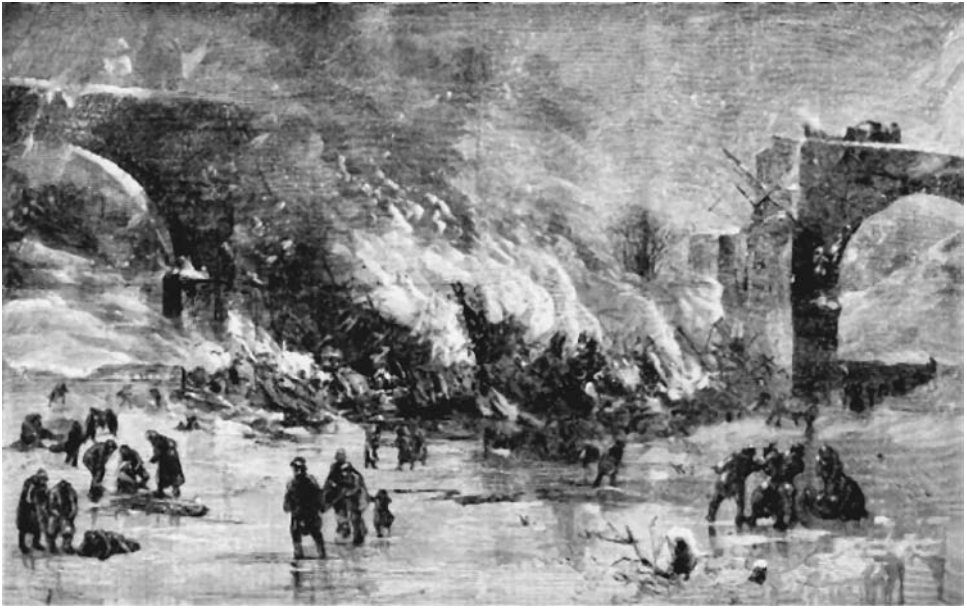
Although many people were estimated to have died instantly in the crash, several passengers also perished in the fire that followed, bringing a total of 92 casualties. The severe fire was a direct result of the fact that each carriage was heated by stoves, besides being lit by oil lamps (Fig. 2.3).

Fig. 2.3 A vivid drawing of the collapse scene (Harper's Weekly, 20 January 1877). ([www.catskillarchive.com/rrextra/wkasht.html](http://www.catskillarchive.com/rrextra/wkasht.html))

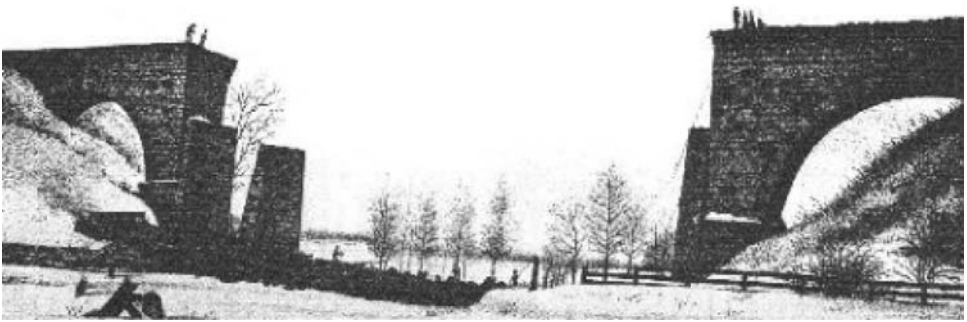
The following day the charred remains of the bridge and the train lay twisted beyond recognition in the river bed below (Fig. 2.4).

Fig. 2.4 The day after the collapse. The extra brick pier that is seen close to the left-hand abutment is from the earlier wooden bridge at this site. (<http://home.alltel.net/arhf/bridge.htm>)

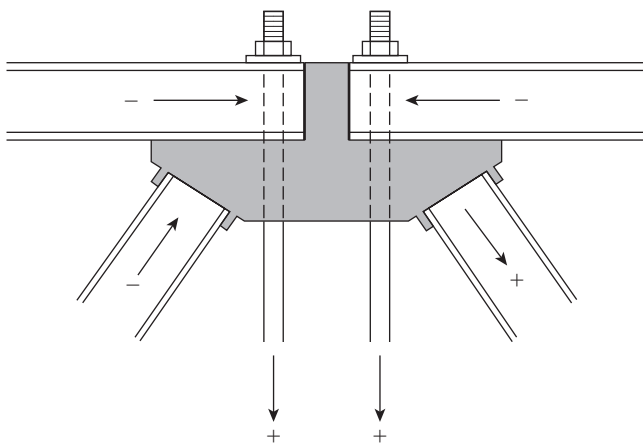
Fig. 2.10 The principal truss joint design of the Ashtabula Bridge – a cast-iron angle block in between the individual members (diagonals, verticals and horizontal chords).

As the diagonals in the Ashtabula Bridge were somewhat loosely fitted to the joints in the panels during assembly, they relied upon the prestressing (read: compacting) to function properly during loading of the truss. The tension diagonals could only carry load below the prestressing level (as a reduction of the compression), and were not able to withstand the full tension capacity of its members (due to the inadequate fastening to the joints).

The joint between the diagonals and the upper and lower chords had the following principal design – a cast-iron angle block supporting, and transferring the forces between the members in the truss (Fig. 2.10).

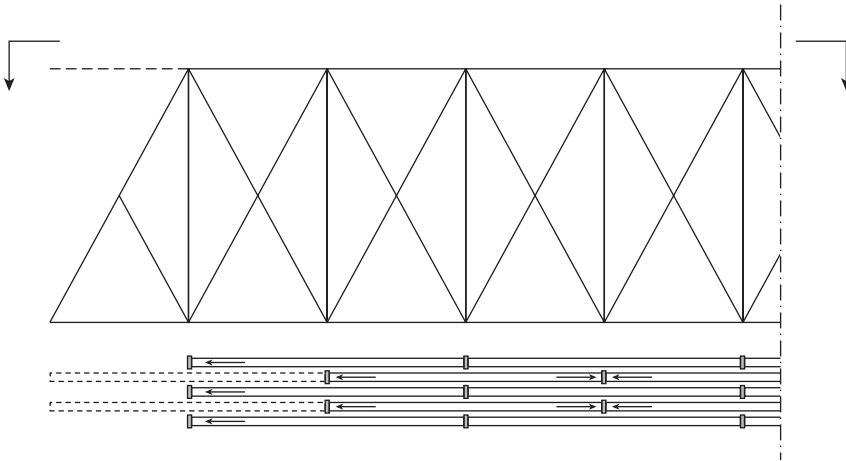
Even though the bridge was considered to be very strong and robust, it was judged “too experimental” by another involved engineer, Mr Charles Collins, and experimental it certainly was. Both the chords and the diagonals consisted of *separate* wrought iron I-girder elements (Fig. 2.11).

Fig. 2.11 The top (compression) chord of the Ashtabula Bridge.

In every other joint in the upper chord, the I-girders were fitted to the lugs on the cast-iron angle blocks by using shims – i.e. thin plates – to fill the small gaps there during the assembly (see Figs. 2.10 and 2.11). In a sense the entire bridge resembled more a gigantic model construction kit – such as a Meccano without nuts and bolts – rather than a normal steel truss of modern standards, which is having the members properly and securely fixed to the joints. Perhaps Amasa Stone had too much of his inspiration coming from the wooden Howe trusses.

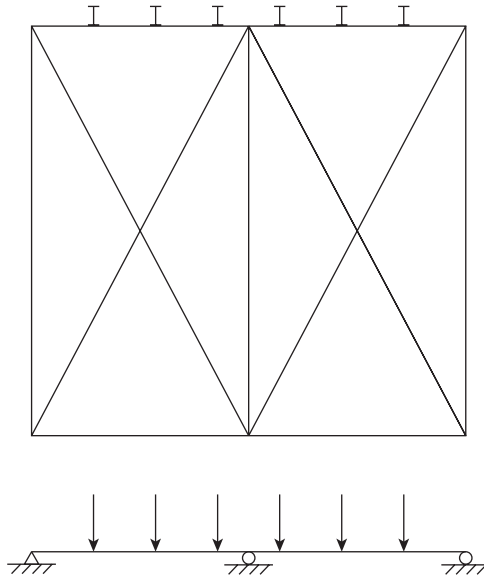
Also the transverse floor-beams (carrying the track) were of the same wrought iron I-girder profiles that were used for the truss members, and these floor-beams were just simply positioned every 1.12 m along the upper chord of the truss (Fig. 2.13).

Fig. 2.13 The upper chord of the trusses had to, besides carrying the normal compressive forces due to the truss action, also – as a continuous beam – carry, in bending, the floor-beams positioned in between the truss joints.

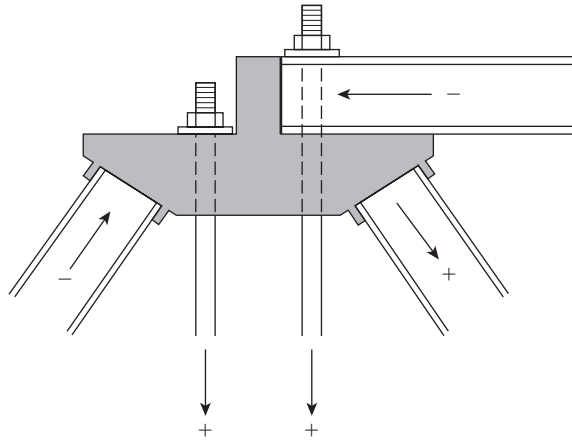
There were five lugs at both ends of the upper compression chord that were having one-sided loading – the two in the second joint were having I-girder elements on either side, however, the two I-girders continuing to the abutment (see Figs. 2.5 and 2.11) are only “zero-bars” with respect to the truss action. The remaining lugs – all having

Fig. 2.15 The one-sided horizontal loading from the upper chord I-girder member to the cast-iron lugs at the ends (see also Fig. 2.10).

active members on both sides (see Fig. 2.10) – had only to transfer (by shear) the small difference in member forces between the horizontal I-girders. It was considered without any risk to choose cast iron for the angle blocks (containing the lugs), as they were to be subjected to compression only, however, the five lugs at the ends must have been somewhat overlooked in the design process. After eleven years of in-service loading one of the lugs broke, which resulted in an instant over-loading of the remaining I-girders in the chord. As the upper chord consequently became eccentrically loaded, it began to buckle outwards in the transverse lateral direction (first perhaps as separate units, and then finally as a complete “package”). There was limited capacity of the upper chord to withstand this excessive loading as the compression members of the bridge had been designed with respect to a stress criterion only, and not with respect to the risk of buckling. (Further, there is the simultaneous transverse vertical loading from the floor-beams.) One could also assume uneven load distribution in between the I-girder elements – prior to the breaking of the lug – due to difference in contact pressure to the lugs. The engine drivers had also for many years experienced a “snapping sound” when trains were passing over the bridge, indicating perhaps that even small gaps (due to the loss of shims) were present between certain compression elements in the bridge (upper chord as well as diagonals). There had also been inspection reports of misalignments – the girder elements were in many cases not meeting the lugs completely straight. Anyway, the upper chord failed in buckling, which resulted in the progressive failure of the entire second truss panel, transforming the inner statically indeterminate truss from a load-carrying structure to a complete mechanism (Fig. 2.16).

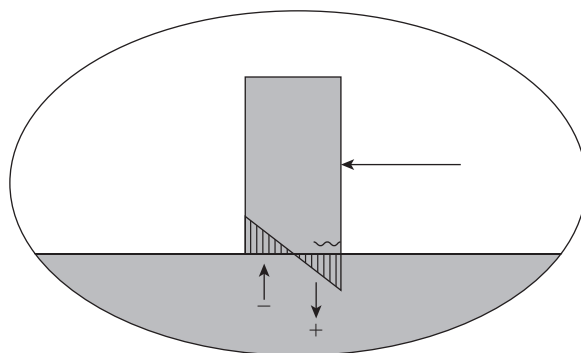
Fig. 2.17 A fatigue crack is formed perpendicular to the tensile stresses at the base of the lug.

have given uneven contact pressure zones, which could explain why some lugs were subjected to bending (and shear) rather than pure shear. When such a lug is repeatedly loaded – especially those at the ends (being loaded from only one side as they were) – a fatigue crack is eventually initiated, and this crack is then propagating horizontally (for every new loading cycle) until it reaches a certain critical length (with respect to brittle fracture of the net section) (Fig. 2.17).

The very low ductility of cast iron leads to small critical crack lengths, but still a crack has to be initiated and then propagate to give a final fracture (in a brittle manner). In addition, there was also the probability of sudden thrusts from the upper chord I-girders to the lugs if they were not exactly in close contact, and this would reduce the fatigue life of the lugs (read: reduce the critical crack length). Furthermore, at the evening of the collapse the temperature was low, which increased the brittleness (read: reduced the fracture toughness) of the cast iron material. There is one other parameter though, which is reducing the load on the lug, and that is the friction (between the I-girders and the horizontal face of the angle blocks), which is due to the pretensioning of the truss and the live load upon the floor-beams.

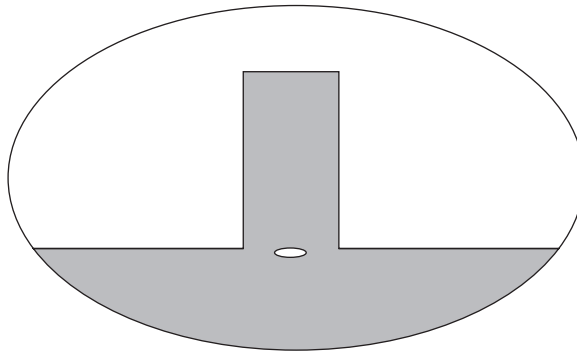
The inquest correctly pinpointed the broken lug as the initiating point for the collapse, but it was not until later that it was found – when examining the lug more in detail – that it contained a large flaw. An air hole (void) was found in the broken lug (Fig. 2.18).

Besides reducing the effective cross-section of the lug (not only the gross section alone, but also the net section after the initiation of the fatigue crack), the void also

Fig. 2.18 When the broken lug was examined a large embedded air hole was found.

acts as a stress raiser due to the stress concentration effect. The transition zone between the lug and the main body of the angle block is also a region where cooling is slow after casting – in such zones there is not only the risk of voids forming (due to “suctions” because of uneven shrinkage of the metal during solidification), but also the formation of large grains, the accumulation of slag inclusions and other impurities, which all result in extra brittle behaviour in such zones. Given this knowledge, it was just pure chance that the lug did not break at first loading.

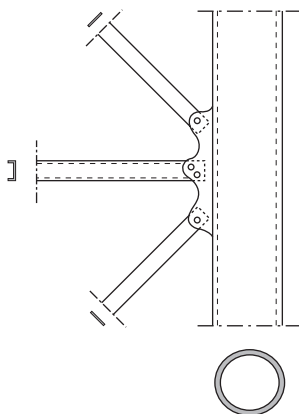
Concentrating on the truss columns in the continued discussion regarding the governing weakness of the bridge, we start with a brief description of the joint configuration. In each joint the wrought-iron horizontals and diagonals were attached (bolted) to the vertical cast-iron cylinders (the circular hollow profiles) through cast-iron gusset plates (lugs), which were cast in the same mould as the cylinder, as integrated parts (Fig. 3.8).

In order to allow for an easy erection of the truss members – especially the diagonals – one end was provided with an elongated hole (to allow for tolerances due to slight differences in length). At assembly the diagonals were fastened to the gusset plates, and then secured and tightened through small tapered cotters (“wedges”) which were fitted in the over-lapping gap. It was these cotters that for some diagonals had worked loose (through the shakings and vibrations), making the function of these truss members heavily impaired – now more or less comparable to a non-active zero bar. But there were other circumstances that made this truss column weaker than perhaps was the intention. By choosing flat bars the diagonals of the truss column could not transfer compressive load due to the negligible buckling strength of these members. So here we had a structure comprising of diagonal elements:

- that easily lost their strength in tension, and
- that were more or less unable to carry any load in compression.

Fig. 3.8 The configuration of the truss column joints. The diagonals were simple flat bars and the horizontal was a U-channel bar (possibly a T-bar).

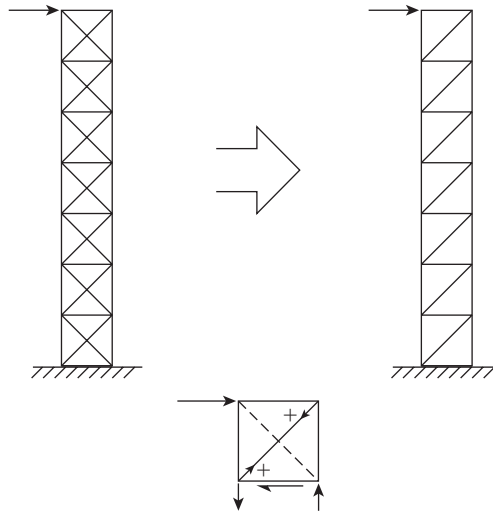
At a first glance the truss column has the appearance of an inner statically indeterminate structure, but which in fact is statically *determinate* due to the inactive compressive diagonals, and could be transformed into a “mechanism” with respect to the action of a true truss (when diagonals in tension also are lost). In comparison to the Ashtabula Bridge – where all members (in tension and in compression) were designed with respect to maximum stress, rather than taking the risk of buckling into account for the members in compression – the Tay Bridge design led to a utilization of the diagonals in tension to twice the intended value. In a truss having equally stiff crossing diagonals, the transfer of load is divided equally in between the diagonals. However, if we study the transfer of a horizontal load in a vertical cantilevering truss – having one of the diagonals in each panel unable to carry load in compression – the resulting action is that the load is transferred down into the base as a constant force (in tension) in only one set of the diagonals (Fig. 3.9).

Fig. 3.9 The resulting transfer of “shear” in a vertical cantilevering truss if one diagonal of each pair in the panels is unable to carry compression (because of a negligible buckling strength).

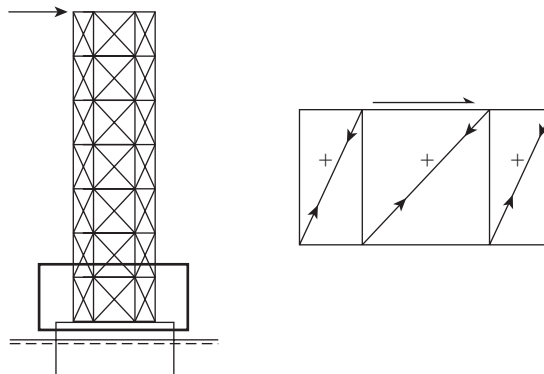
Fig. 3.10 The resulting action of the bottom panels in the truss column (as well as every set of panels), considering that the diagonals in compression are inactive.

The major part of the horizontal load is transferred down through tension in the active diagonal of the inner panel, and if this diagonal is lost – having worked loose due to the loss of the cotters, or due to local failure of the connection – then all load has to be taken by the remaining two diagonals in the outside panels.

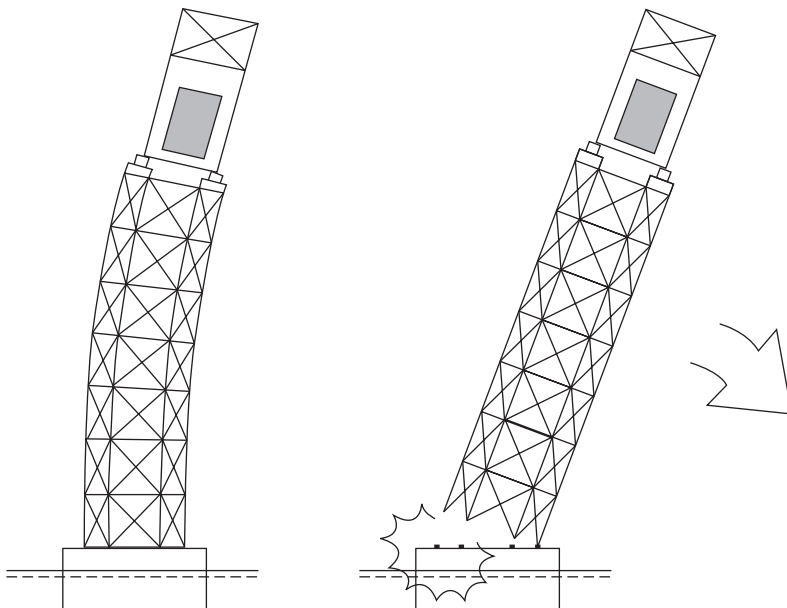
The maximum pressure came from the wind gusts, exerting not only a maximum deflection of the truss columns in the wind direction, but also, most probably initiating resonant vibration (swaying) which amplified the forces – at the base of the truss columns – and the deflections of an already weakened structure, which finally became too much for the bridge to carry (Fig. 3.15).

Fig. 3.15 The progressive failure of the high-girder section of the Tay Bridge.

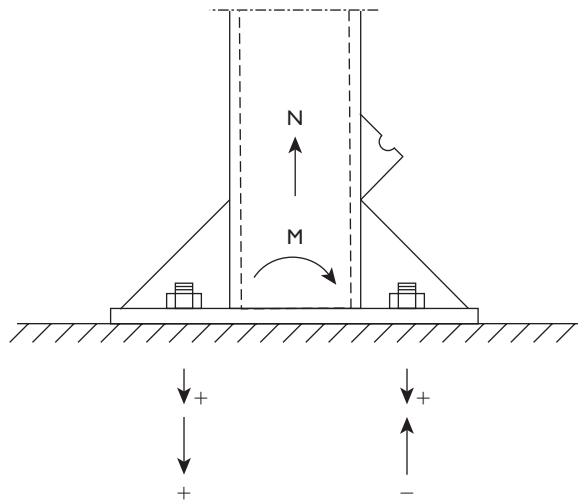
Ten out of twelve truss columns fractured at the base (to the piers) due to a sudden loss of anchorage (one after the other) and the remaining two fractured some few metres above the base. As the diagonals had lost their strength – during the eighteen months the bridge had been in service and during the final stages of the progressive collapse – the loading at the base of the cylinders changed from being pure normal forces to the combination of normal force plus bending moment, neglecting the shear force being present. Here only the action coming from the horizontal wind load is shown (not considering the vertical compression coming from the weight of the train) (Fig. 3.16, see also Fig. 3.11).

Fig. 3.16 As the diagonals were lost the loading at the base of the cylinders increased dramatically. Also shown above is the fractured gusset plate where the diagonal had been connected.

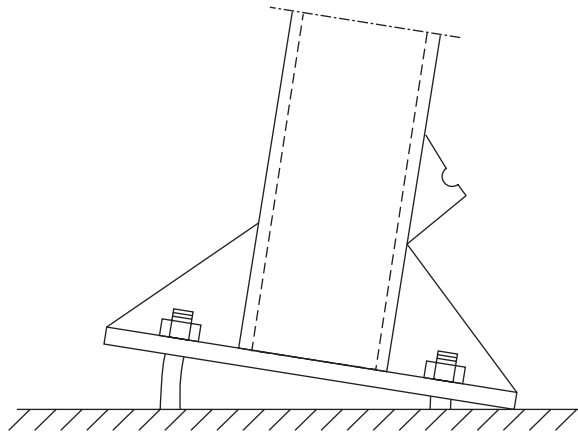
Fig. 3.17 Elongated and deformed anchorage bolt on the tension side of the cylinder base plate.

As a consequence the anchorage bolt at the tension side became overstressed (Fig. 3.17).

Afterwards, when the piers were examined, they found a large number of nuts and bolts together with broken-off pieces from the gusset plates (the outside parts after fracture of the net-section through the bolt holes – the missing parts of the gusset plates in Figs. 3.16 and 3.17).

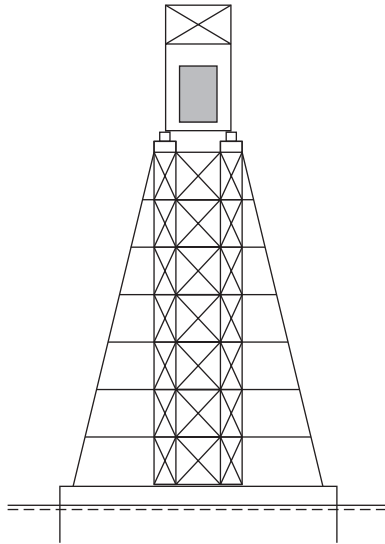
The Court of Inquiry concluded that “the fall of the bridge was occasioned by the insufficiency of the cross bracing and its fastenings to sustain the force of the gale”, and indeed so it was. The high-girder section of the bridge would definitely have benefited from an extra pair of straddling legs (like the intuitive position of a human body expecting a horizontal thrust), stabilizing the truss columns and drastically lowering the strain due to severe winds (Fig. 3.19).

Fig. 3.19 An extra pair of straddling legs would most probably have saved the Tay Bridge.

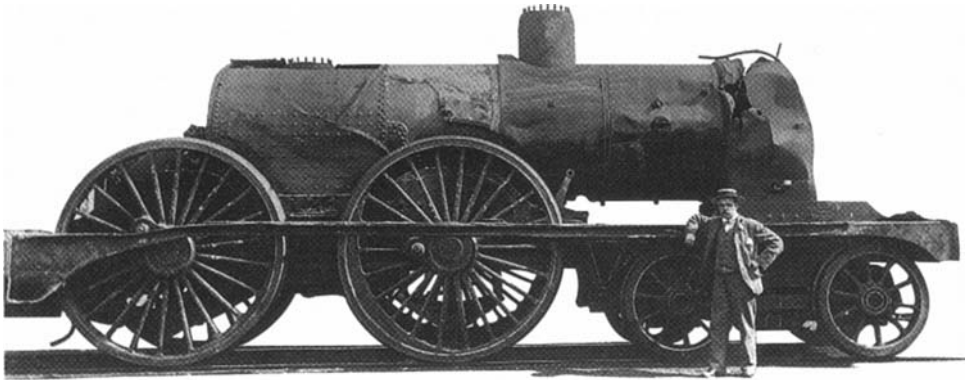
The deck girders from the old Tay Bridge were not the only parts that were re-used, but also the engine of the mail train was taken into service again, as it was salvaged from the wreckage of the bridge and repaired (Fig. 3.22).

Fig. 3.22 The engine that was salvaged from the collapse of the Tay Bridge – “The Diver” as it was called. (Yapp, N.: 150 Years of Photo Journalism)

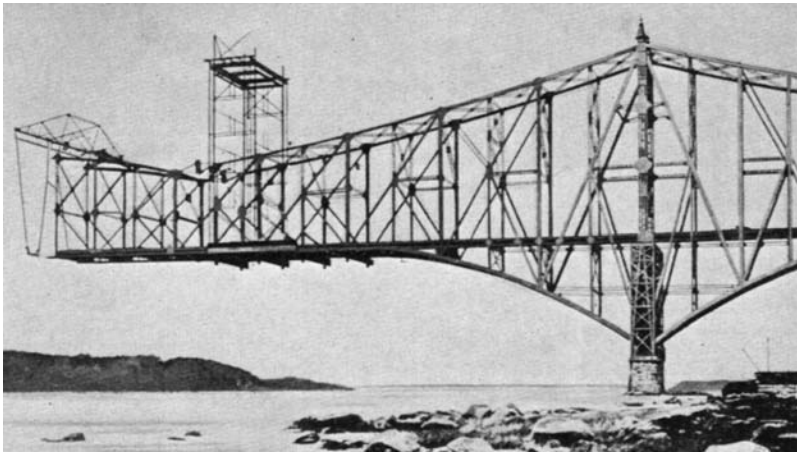
In late summer of 1907 – three years after the start of the construction of the steel superstructure – the cantilever arm reached 223 m out over the river (Fig. 4.8).

*Fig. 4.8* The south cantilever arm and the first three panels of the suspended span of the Quebec Bridge extending 223 m out over the St. Lawrence River in late summer of 1907 (see also Fig. 4.9). In comparison to the massive Forth Bridge (see Fig. 3.23) this structure looks for sure anything but “bulky”. (Hammond: Engineering Structural Failures – the causes and results of failure in modern structures of various types)

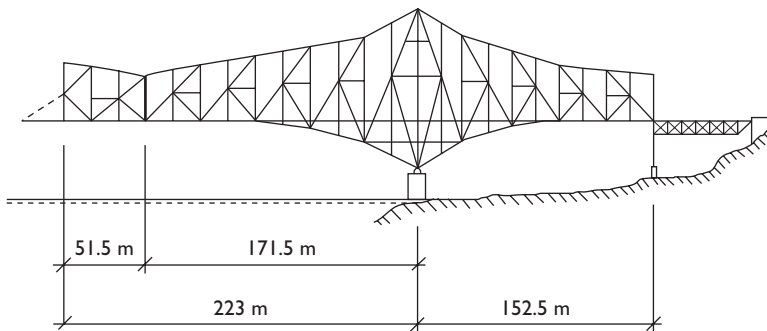
The suspended mid-span section (see Fig. 4.2) had temporarily to be fixed to the ends of the two cantilever arms during erection – when the two cantilevers finally were to meet and closed in the middle, then the fixed ends of the suspended span were to be released. In this stage of the construction we have in a way two cantilevers – first the 171.5 m long cantilever arm, and then a 51.5 m long part of the suspended span extending from the nose of the cantilever arm (Fig. 4.9).

*Fig. 4.9* The south half of the Quebec Bridge extending 223 m out over the St. Lawrence River, balanced by the 152.5 m long anchor arm. Three panels are remaining (i.e. 51.5 m) of the suspended span to the mid-point of the bridge (see also Fig. 4.2).

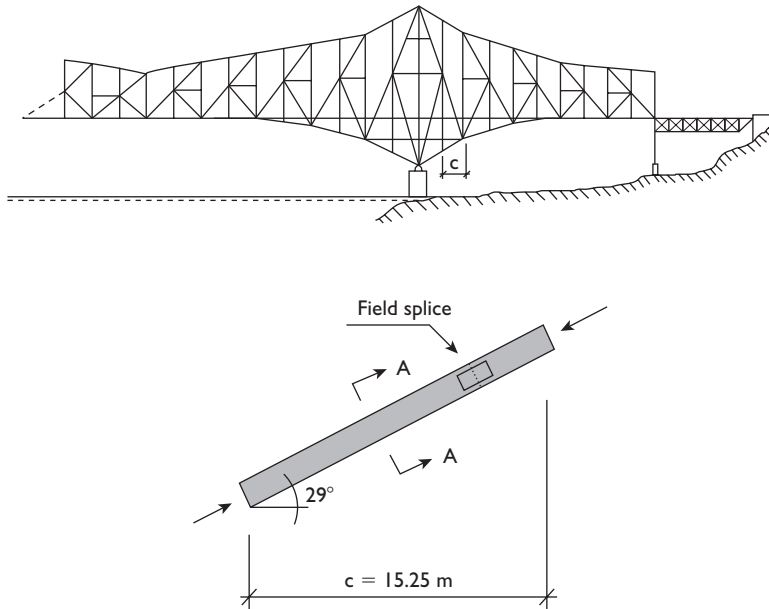
In mid summer of 1907 the first signs of distress in the steel superstructure began to show – a field splice in the ninth panel lower compression chord on the left-hand side of the anchor arm (member A9-L) had become distorted (Fig. 4.10).

Fig. 4.10 The lower compression chord in the ninth panel of the south anchor arm (member A9-L), where distortion of the field splice was detected in July 1907.

At the end of August – when the cantilever had been extended further out over the river, increasing the stresses even more in the truss members – it was found that the out-of-plane bending of chord A9-L had increased from some 20 mm to alarmingly 57 mm. Even though this deformation – representing an out-of-plane deflection of  $L/305$  (the length  $L$  of the member being 17.44 m) – is hard to detect by the naked eye, it was a clear signal that something was quite wrong. And visible signals were also given, as rivets for the transverse bracing members (the diagonal and horizontal L-profiles – see Fig. 4.12) began shearing off – a clear evidence of the excessive out-of-plane bending taking place. Realizing the danger McLure immediately travelled to New York on the 27 August to consult with Cooper (telephoning was judged to be too risky – there was always the possibility that the telephone operator would listen in and reveal the situation to the newspapers). Cooper, realizing the danger of the situation, wanting the construction to come to an immediate halt, telegraphed to the Phoenix Bridge Company: “*Add no more load till after due consideration of facts*”. However, the contractor (i.e. the Phoenix Bridge Company) was under great pressure not to delay the construction, so the work continued by unfortunately moving an erection crane one step further out on the cantilever. If they had listened to the message from Cooper,

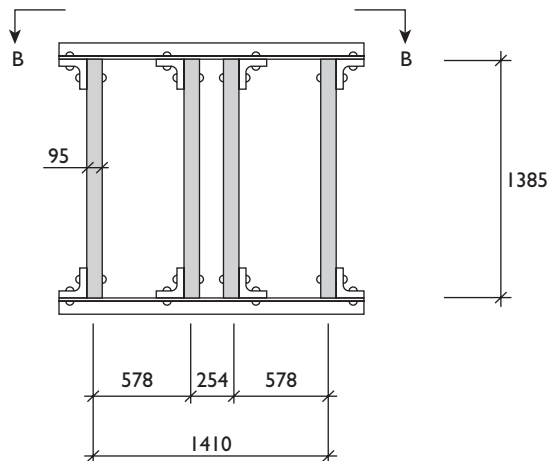
While the Forth Bridge had circular tubes the Quebec Bridge had riveted built-up rectangular truss members. The lower compression chord in panel nine of the south anchor arm consisted of four parallel steel plates,  $95 \times 1385 \text{ mm}^2$  (each consisting of four 23.8 mm thick plates being clamped together by rivets) (Fig. 4.11).

Fig. 4.11 The cross-section of the anchor arm lower compression chord in panel nine (section A-A in Fig. 4.10).

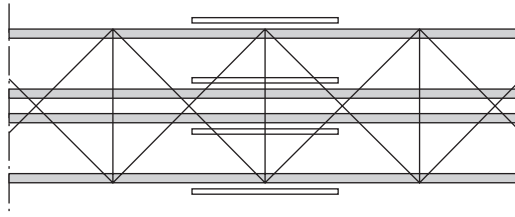
Close to the upper joint of the compression chord in panel nine (at a distance of some 20% of the member length) the web plates were spliced with cover plates (see also Fig. 4.10) (Fig. 4.12).

As the lower chords of the anchor arm initially were subjected to tension – when the falsework was removed and the span became simply supported – and the normal force soon changed to compression as the cantilever arm grew outwards, it was decided to temporarily use bolts in order to allow for the structure (the anchor arm) to develop all of its deformations (read: the gradual elongation/compression of the upper and

Fig. 4.12 The web splice (spliced in field and not in shop) of the lower chord in panel nine – section B-B in Figure 4.11, i.e. the top view (however, rotated 90°). Also shown are the stabilizing members in the transverse direction – crossing diagonals and horizontals of small L-profiles.

lower chords) before riveting the plates tight together. The anchor arm was quite simply judged to be allowed to adjust itself to the changing load, otherwise secondary constraints could have been developed. However, by taking this measure the buckling strength of the lower compression chords became affected negatively. Besides having observed local distortion of the plates in the field splice, it was discovered in the beginning of August 1907 that chord A9-L was slightly bent out-of-plane as well. The representatives of the Phoenix Bridge Company claimed that the deformations were the result of an incident which had taken place in 1905, when this particular chord had been dropped and bent in the storage yard. Bridge inspector McLure – Cooper's assistant at the bridge site – was, however, convinced of that the deformations had taken place *after* that the chord had been installed, and he was supported by Cooper who suggested that it was most probably a hit damage during construction. In the discussions it was more a matter *when* the chord had been bent rather than if this in any way could affect the safety of the bridge. The concentration was also focused on the construction of the cantilever arm, and not to the more or less already completed anchor arm, so the matter was perhaps not given the highest priority.

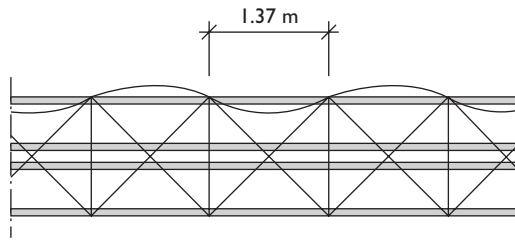
Fig. 4.14 The possible failure mode of an individual web plate buckling independently of the others.

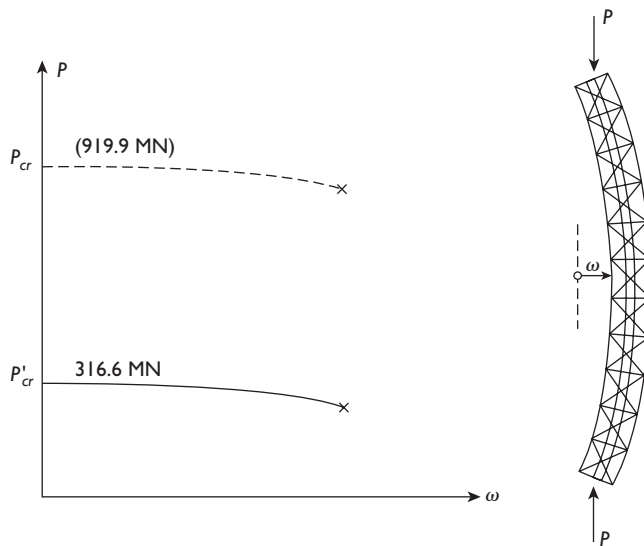
Fig. 4.17 Load/displacement-diagram showing the critical buckling loads in the global out-of-plane direction for full and complete composite action ( $P_{cr}$ ) and for the case when the flexibility of the stiffening truss is taken into consideration ( $P'_{cr}$ ).

In a graph we could also visually see that the critical buckling load in the global out-of-plane direction has been reduced to almost one third of the value assumed by Cooper (Fig. 4.17).

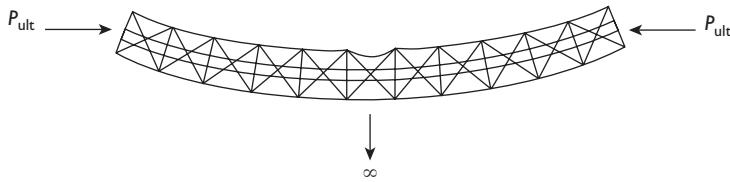
Fig. 4.21 Local buckling of the web plate on the concave side triggered most probably the collapse.

For the case of the built-up sections of the Quebec Bridge yielding of the web plate at the concave side (for out-of-plane bending) was probably not the triggering factor for the collapse of the chord, instead local (Euler) buckling in between the horizontals of the transverse stiffening truss was more probably the initiating cause – starting with the web plate on the concave side having the highest combined effect of normal force stresses and secondary bending stresses (besides the presence of the residual stresses) (Fig. 4.21).

As local buckling of the web plate on the concave side took place then there was nothing to stop the collapse of the chord (the remaining three web plates in the damaged panel were unable to carry the load as the eccentricity of the normal force increased drastically). The whole loading procedure was just like a gigantic full-scale load test until failure; a step by step increase in load and a simultaneous monitoring of the deformations, just as it is done in a laboratory – the only difference being that here it was performed in field conditions, in a real load-carrying structure. Starting with an already damaged (read: initially bent) chord there was a gradual increase in loading – and out-of-plane deflections – until the ultimate load-carrying capacity was reached (Fig. 4.22).

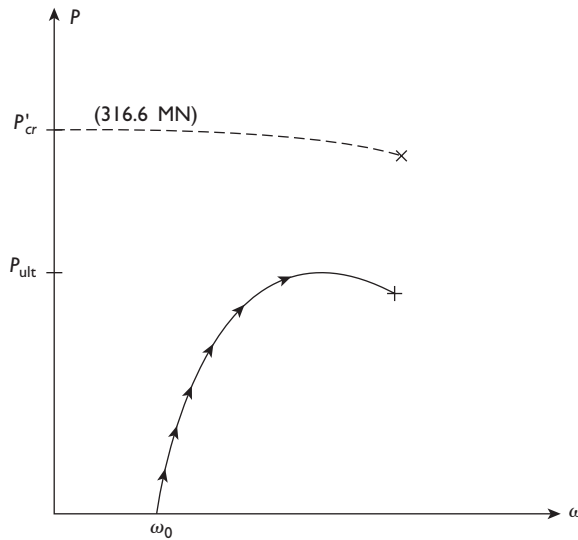
Fig. 4.22 The true load/deformation-relationship (in principal), well below that of the theoretical response assuming an ideal and perfect chord. The actual loading procedure was just like following a gigantic load test until failure.

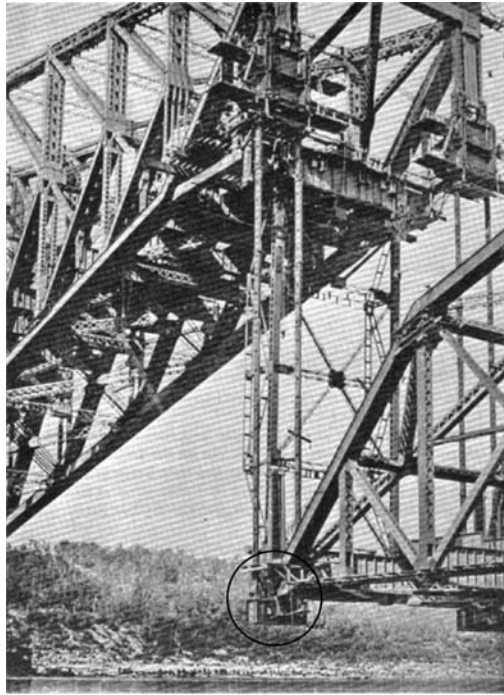
When the suspended span had been lifted 9 metres up above the water level there was a crash due to the sudden collapse of one of the corner bearings. Immediately the eccentric loading became too much for the remaining bearings to carry (more or less

Fig. 4.25 A close-up of the hanger arm and one of the corner bearings. (Hammond: Engineering Structural Failures – the causes and results of failure in modern structures of various types)

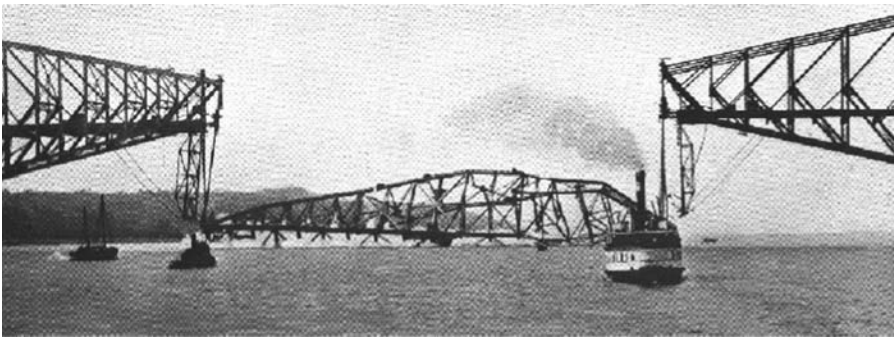
Fig. 4.26 The second failure in September 1916 in the construction of the Quebec Bridge (quite a remarkable picture taken by a very alert photographer). ([www.civeng.carleton.ca/Exhibits/Quebec\\_Bridge/intro.html](http://www.civeng.carleton.ca/Exhibits/Quebec_Bridge/intro.html))

twice the loading for the intact diagonal corner bearings), so the entire span crashed down into the river, twisted and deformed (Fig. 4.26).

This time 13 workers were killed (in addition to the 75 already lost in the first collapse in 1907). There were many theories put forward for the reason of the failure,

but it was finally attributed to inadequate strength of the connection detail due to a faulty design.

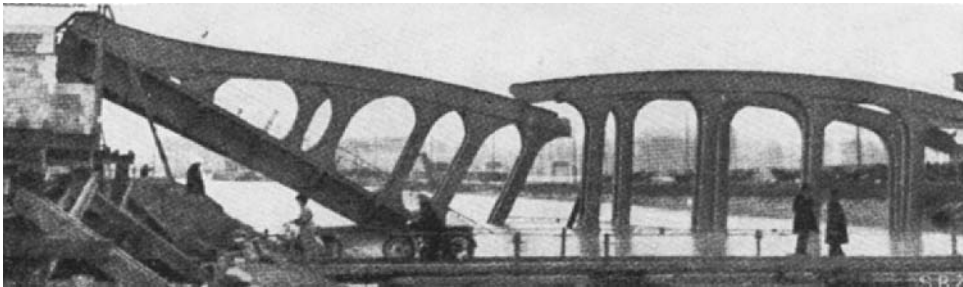
On a cold morning in March 1938, the Hasselt Road Bridge in Belgium suddenly and unexpectedly collapsed and fell into the Albert Canal, less than two years after its completion (Fig. 5.1).

Fig. 5.1 The collapse in March 1938 of the Hasselt Road Bridge over the Albert Canal in Belgium. (Stålbygge. Utdrag ur Stålbyggnad, programskrift 11)

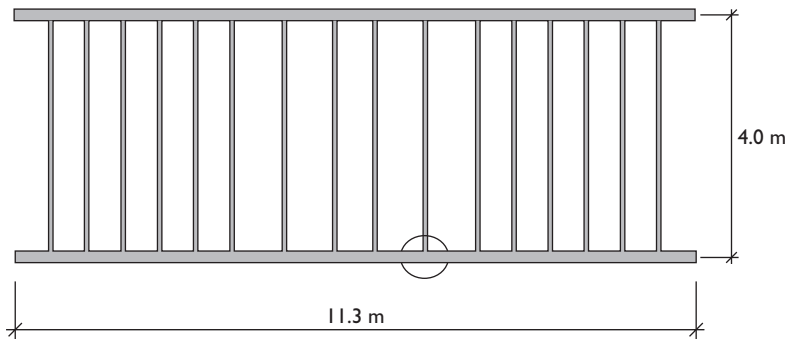
The  $11.3 \times 4.0 \text{ m}^2$  cross-section of this temporary timber bridge construction consisted of two compact timber flanges, separated by a large number of internal lattice walls (Figs. 6.3 and 6.5).

Fig. 6.3 The cross-section of the timber arch falsework for the Sandö Bridge.

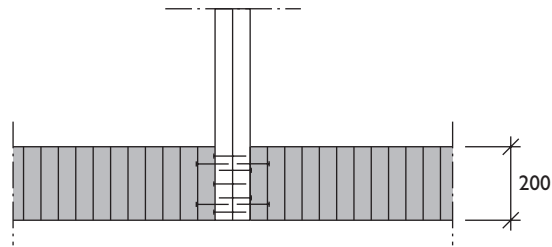
The timber lattice walls were connected and fitted to the flanges through nailing, and the flanges – also nailed together – consisted of more than 220 individual pieces of timber, each having the dimension of  $50 \times 200 \text{ mm}^2$  (Fig. 6.4).

Fig. 6.4 The built-up bottom flange and internal timber wall connection.

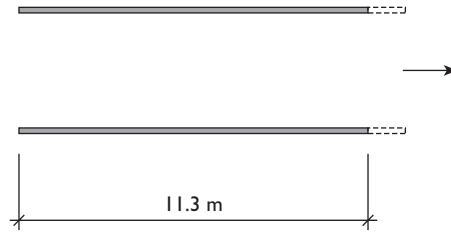
Fig. 6.7 Buckling direction, i.e. in the stiff direction of the flanges.

stiffness of the built-up flanges were too weak to resist lateral buckling. If we – for the sake of discussion – start by calculating the bending stiffness of the two flanges (as a coupled pair) in order to find the critical buckling load, assuming *full interaction* between the joined timber parts, we find (Eqs. 6.1 and 6.2, Fig. 6.7):

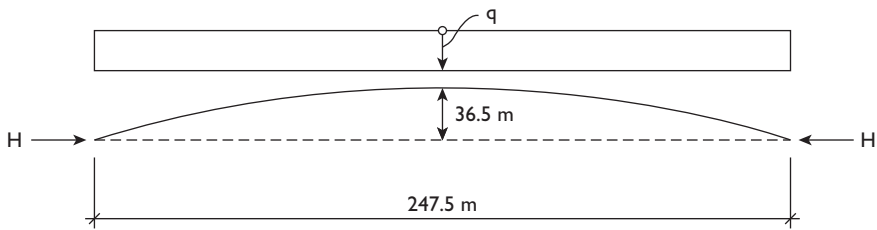
If we use the actual values for  $L$  and  $f$  (see Fig. 6.8), we finally have the critical buckling load, where we have assumed full interaction between the individual timber elements in the flanges (Eq. 6.4, Fig. 6.8):

Fig. 6.8 The span length and rise of the timber arch.

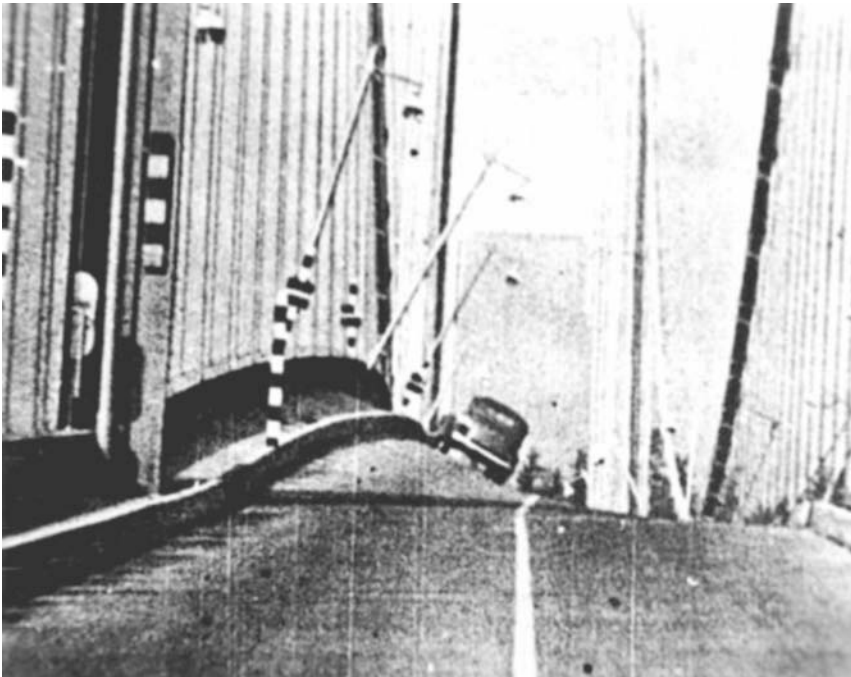
"The motion pictures of the twisting span are unforgettable, and the distortions they depict, in character and magnitude, are almost unbelievable. The span twists in gigantic waves, and it is difficult to realize that the girders were made, not of rubber, but of structural steel having a modulus of elasticity of 29,000,000 pounds per square inch (200,000 MPa)." (Fig. 7.5).

Fig. 7.5 A still from a classic live film of the twisting span, showing a car left out on the bridge, abandoned by a newspaper reporter. (University of Washington Libraries, Special Collections, UW 21429)
