# Understanding Bridge Collapses

**Björn Åkesson**

*Consulting Engineer, Fagersta, Sweden*

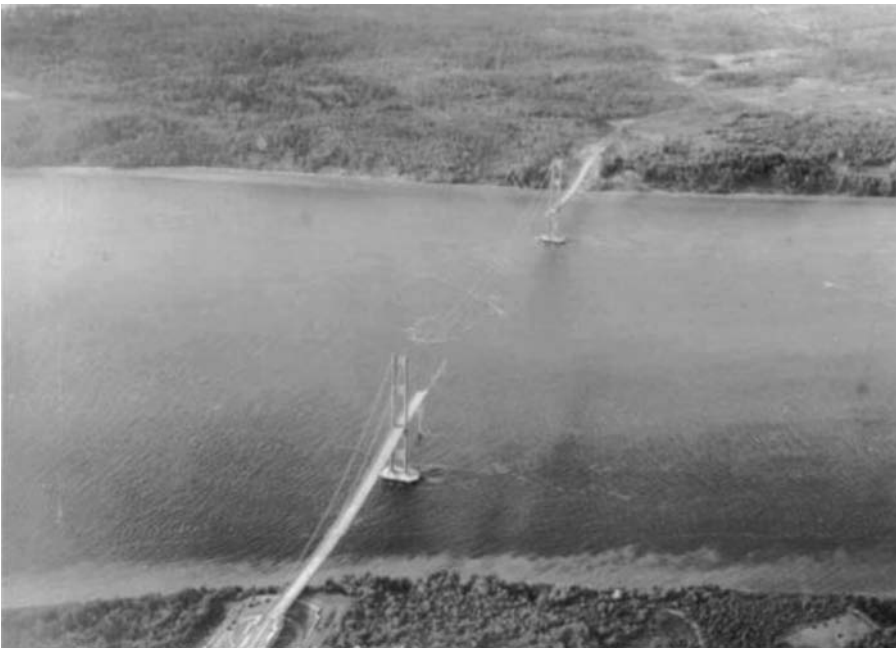
Apart from some short ends of the bridge deck only the two suspension cables remained of the main span (Fig. 7.8).

*Fig. 7.8* The collapsed Tacoma Narrows Bridge – aerial view looking west, a rather sad and dreary sight. (University of Washington Libraries, Special Collections, UW 26818z)

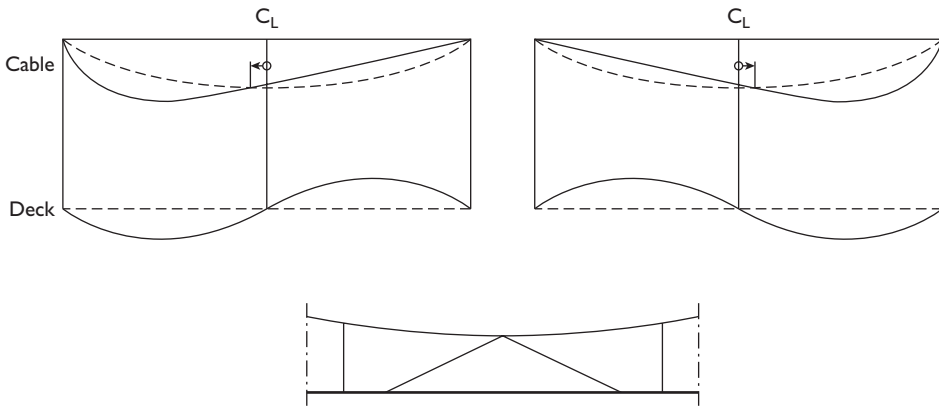
Fig. 7.12 By locking the cable at midspan, e.g. by inclined hangers (centre ties), the vibration of the bridge deck can be limited.

One way of limiting these kinds of vibrations is to lock the cable at midspan, as the midpoint of the cable is moving back and forth when the cable is stretched (in relation to the midpoint of the deck that is) (Fig. 7.12).

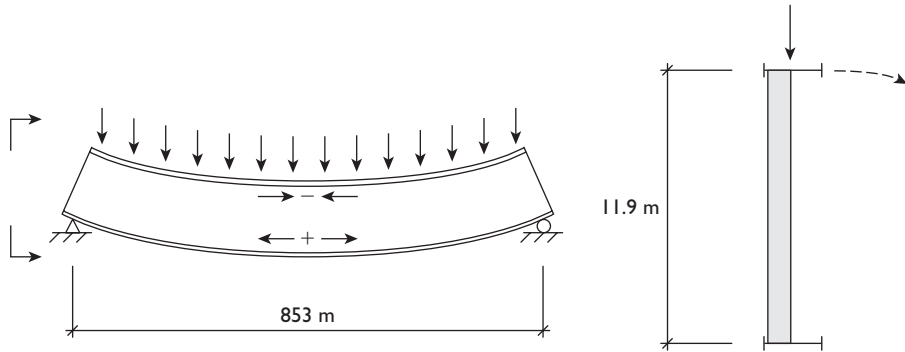
A triggering factor with respect to the torsional oscillations – besides vortex shedding – may also have been a phenomenon which is called lateral/torsional buckling. As the wind is pushing the bridge deck horizontally, the two end girders act as two flanges – separated apart by the deck – in a deep beam (which is on the flat). Compression stresses are formed in the end girder at the windward side and tension stresses in the other end girder at the leeward side, and the compression flange could buckle transverse to the wind loading direction (if the wind is strong enough that is) (Fig. 7.15).

Fig. 7.15 The 853 metre long bridge deck as a simply supported deep beam (should in fact be continuous in three spans), with possible lateral/torsional buckling risk.

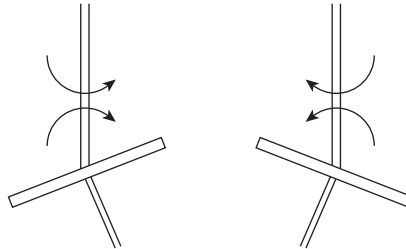
Fig. 7.16 Local bending of the hanger connections as the bridge deck was twisting back and forth made the bridge eventually collapse – a typical case of low-cycle bending fatigue.

Then, what was it that finally made the bridge deck to break from the vertical hangers and fall into the water below? Of course the bending and twisting deformations of the deck itself were excessive (however, as the flexibility was low no destructive strains were produced), the key failure mechanism was instead the *local* bending of the connection detail between the hangers and the end girders (Fig. 7.16).

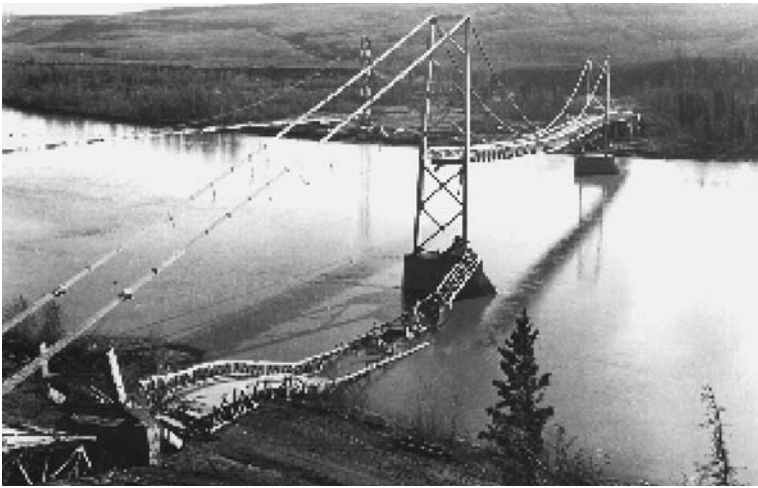
Fig. 8.11 The collapsed Peace River Bridge. ([http://collections.ic.gc.ca/north\\_peace/transport/02.07.html](http://collections.ic.gc.ca/north_peace/transport/02.07.html))

to come – had created the bump experienced by the drivers (as a misalignment of the deck either at the transition between end span and the suspended side span – i.e. at the cable bent – or possibly between the side span and the main span). The inspection personnel immediately realized the danger and closed the bridge to traffic. Just as the case was for the Tacoma Narrows Bridge the collapse of the Peace River Bridge came several hours later, so a large crowd of people could gather and witness the actual collapse. Suddenly, at approximately one o'clock in the afternoon, the north abutment slid towards the river some 3.5 metres and the end span and north suspended side span collapsed simultaneously (Fig. 8.11).

Whether the actual slide of the north abutment was because of a reduced capacity to resist the pulling force of the cables – because of the saturation of the ground – or that a landslide had been initiated, taking the abutment and the surrounding soil (or perhaps even the mudstone) with it, has not to this day been established. The actual collapse sequence was, however, as follows; as the abutment slid forward the cables slackened – transferring the self-weight of the end span to the end span itself (which deflected just as the end span of the Tacoma Narrows Bridge did – see Fig. 7.7 for comparison – however, this time not because of the lack of counterbalancing weight from a collapsed main span). The cable bent became eccentrically loaded and deformed heavily under the combined action of bending and axial normal force, which made it buckle and break (Fig. 8.12).

The end span could of course also have helped to push the cable bent forward – even though the end span is not shown in the figure above – as soon as it came in contact with the front wall of the abutment that is. The broken and deformed cable bent can be seen lying on the ground to the left in figure 8.11, leaning backwards supported by its plinth (and behind it the collapsed end span). In the same figure the deflected main span can be seen – it oscillated heavily at the time of the collapse, but was not

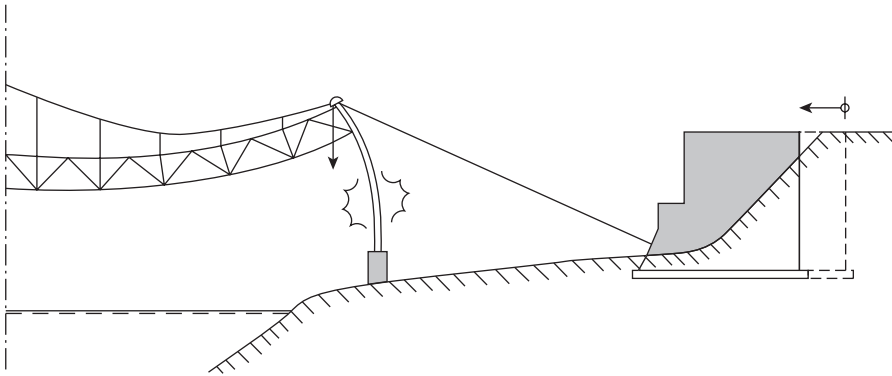
Fig. 8.12 The deformation of the cable bent as the abutment slid.

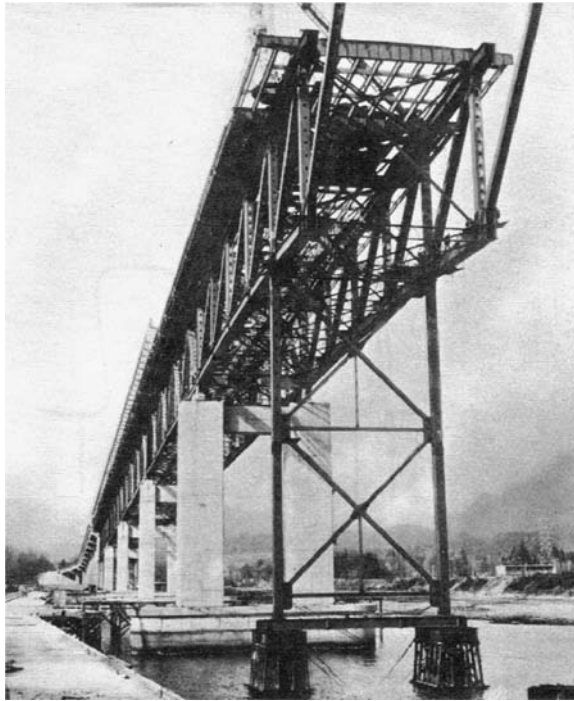
Fig. 9.3 The temporary truss (i.e. the falsework) supporting the north anchor span during construction. (McGuire: Steel Structures. With kind permission of Pearson Education Publications).

At the time of the collapse the north anchor span was being erected, and in order to reduce the maximum cantilever length a centrally located falsework support was being used. In contrast to the anchor spans of the Quebec Bridge back in 1907 – which were constructed using an all-span length falsework (see Fig. 4.6) – it was in this case decided to limit the amount of extra supports to just one because of the water (Fig. 9.3).

In figure 9.3 it is indicated that vertical web stiffeners *actually were* used, however, not directly under the load application points (and these indications could also very well be just bolting, holding the grillage tight together).

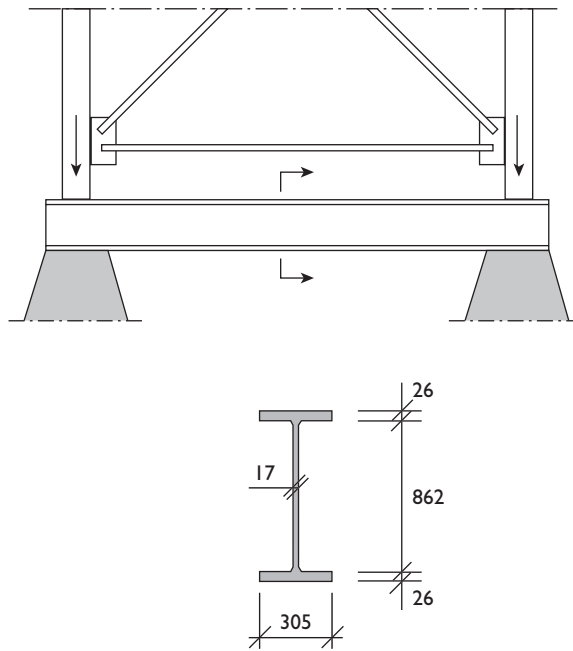
When the anchor span fell the adjacent span also collapsed, as it lost its support when the pier was pulled away. A total of 18 workmen and engineers were killed. A Royal Commission of Inquiry investigated the cause of the collapse and soon found the answer. It was not the buckling capacity of the temporary truss that was inadequate, as could have been expected; instead it was found that the lower transverse beam at the bottom of the falsework truss had failed. The purpose of this beam was to distribute the concentrated load – coming from the vertical members of the truss – in order to spread it over a larger area on top of the piles. The profile – or profiles, for there were probably more than one, lying parallel close to each other as a grillage – was a wide-flanged rolled standard steel girder (36 WF 160) (Fig. 9.5).

Fig. 9.5 Cross-section of the transverse girder.

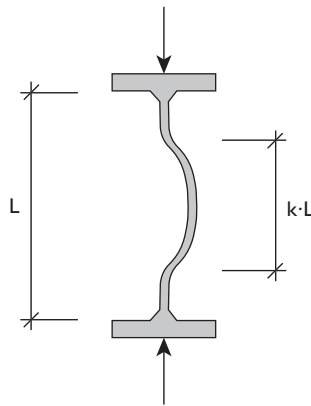
As the concentrated load is transferred directly through the web to the support there is no risk of web crippling (i.e. local buckling of the upper part of the web) as no shear force is present (i.e. the girder is not subjected to bending), instead the instability phenomenon to consider in design should be global buckling of the entire web – an instability phenomenon that is more or less similar to the Euler buckling case where both ends of a strut are fixed (Fig. 9.6).

Fig. 9.6 Overall buckling of the entire web when the load is transferred directly through the web (with a column effective length factor  $k$  equal to 0.5).

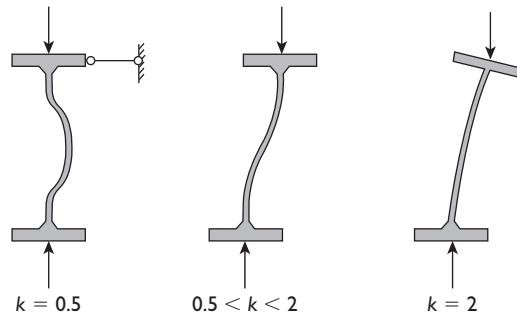
If the upper flange, though, is not fixed in the transverse direction, the effective length factor is somewhere in between fixed end conditions ( $k=0.5$ ) and that of a free-swaying cantilever ( $k=2.0$ ), which have the result that the capacity to carry concentrated loads is lowered even further (Fig. 9.7).

Fig. 9.7 The effective length factor  $k$  with respect to web buckling for different boundary conditions.

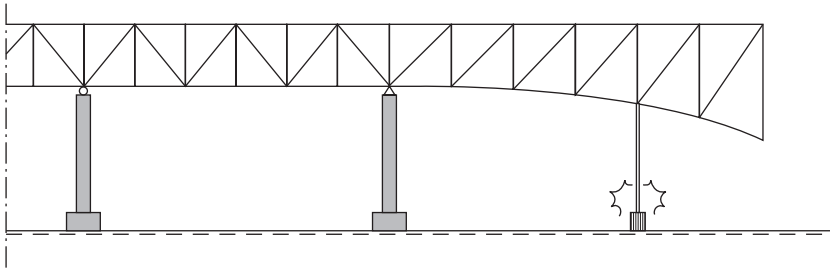
The exact conditions for the transverse girder(s) is difficult to ascertain in detail, but nevertheless, the capacity was far from being enough as the huge cantilever up above lost its temporary support and plunged into the water below (Fig. 9.8).

Swan, Wooster & Partners – the designer of the bridge – shamefully blamed the error in design on a young and inexperienced engineer, who, as a matter of fact, was among the casualties. This engineer was supposedly to have used the flange thickness (26 mm)

Fig. 9.8 When the web of the temporary transverse girder below buckled the entire weight of the cantilever above was transferred to the truss itself – which it had not been designed for – so it broke in bending and collapsed (see also Fig. 9.4).

instead of the web thickness (17 mm) in computing the resistance of the transverse girder to concentrated loads, but even if this is true there are two remarks to be made. First, that there, as a rule, *never* should be relied upon an unstiffened web to carry a concentrated load, whatever the real capacity is, and secondly, that any computation made by an inexperienced engineer at a company should, also as a rule, be checked (and double-checked) by his supervisor (a senior engineer at the office). The company should then stand united and not blame one of their employees if a mistake is made!

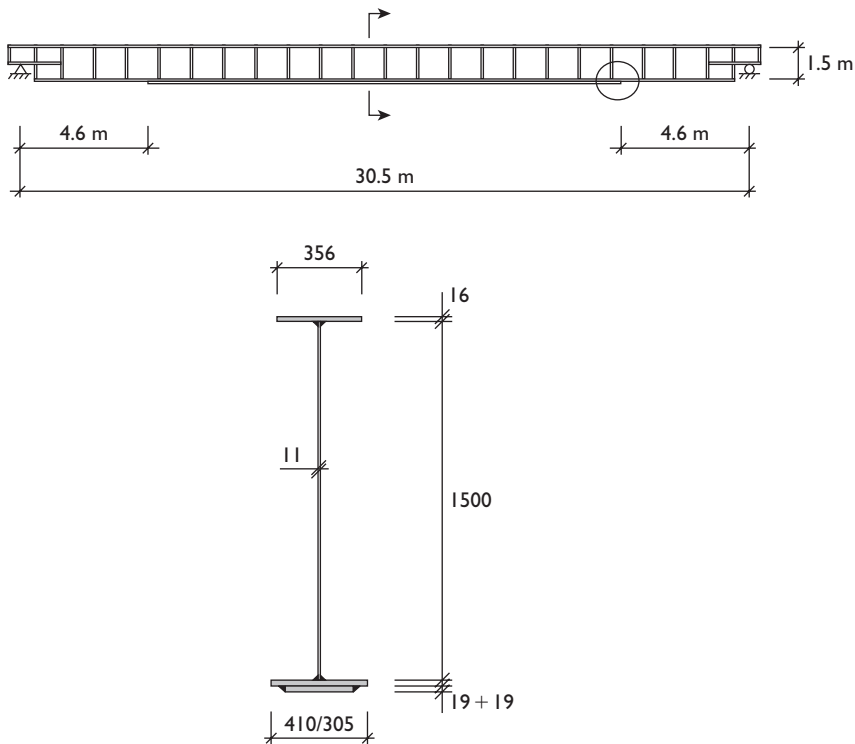
Fig. 10.3 Elevation and cross-section of the *outer* girders of the second span on the south end of the bridge. The inner girders had 356 millimetre wide cover plates, which were terminated 5.3 metres (instead of 4.6 metres) from the ends.

winter's morning, as a 45-ton heavy vehicle was passing over the second span on the western carriageway – having approached the bridge from the south – this span broke and collapsed. The span was 30.5 metre long and the I-girders were reinforced by extra cover plates attached to the tension flange in the maximum-moment region (Fig. 10.3).

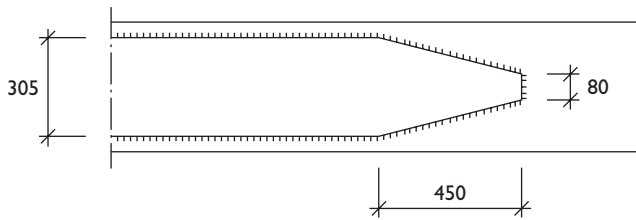
In order to achieve a smooth transition – rather than an abrupt change in stiffness – the cover plates were tapered (i.e. gradually reduced in width) at the ends (the south end encircled in Fig. 10.3) (Fig. 10.4).

Fig. 10.4 The cover plates were tapered over a length of 450 millimetres. Fillet weld dimension: 5 mm – automatic welding for the parallel sides, and manual welding for the tapering and the 80 mm transverse end.

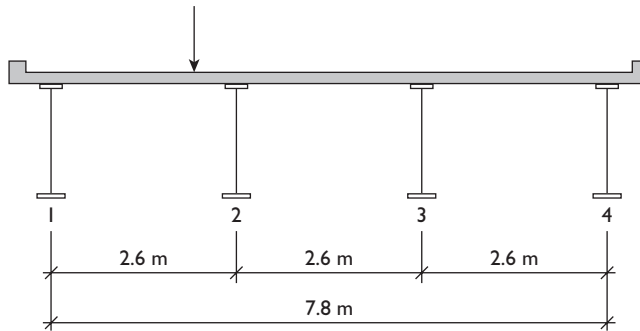
When the lorry passed over the second span on the western carriageway the position was in between girders number one and two (Fig. 10.5).

Fig. 10.5 Cross-section of the second span on the south end of the Kings Bridge, and the approximate position of the lorry that initiated the collapse.

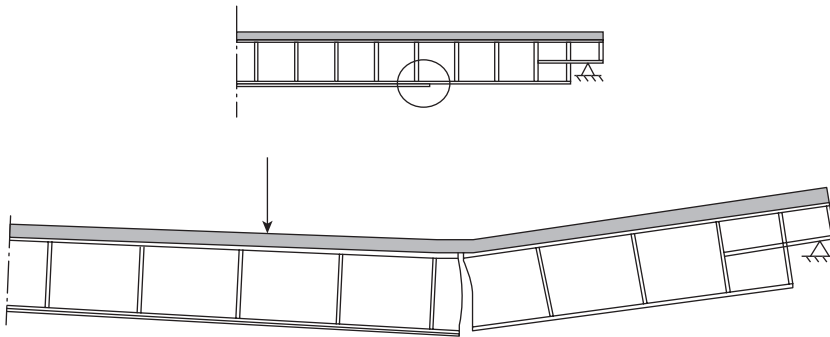
Fig. 10.6 The broken girders.

It was found that all four girders had fractured in a brittle manner in the position of the cover plate ends (Figs. 10.6 and 10.7).

When the cracked girders were examined closer in detail after the collapse, it was found that all the fractured locations had *existing cracks* originating already from when the girders were manufactured or close in time thereafter. The evidence for this was because of the crack surfaces were either covered with paint or being corroded. These

existing cracks had in general a width equal to the width of the cover plate end (i.e. 80 mm) and extended as far as through the flange plate and 25 millimetres up into the web. In one case though, at the south end of girder No. 2, the crack had propagated a long distance up into the web (1100 mm), as well as having fractured the entire lower flange – thus having a load-carrying capacity being more or less completely gone already from the start (or perhaps more probable, some time during the first winter, that is, in 1961). At the time of the failure of the span, one year later, the three remaining intact girders were not able to carry the heavy load so they broke (at the same time as the net-section of girder No. 2's south end also broke). The combined effect of a heavy vehicle, impact loading, existing cracks and low temperature (it was  $+7^{\circ}\text{C}$  that morning, and  $+2^{\circ}\text{C}$  during the night) made the girders break. The Royal commission

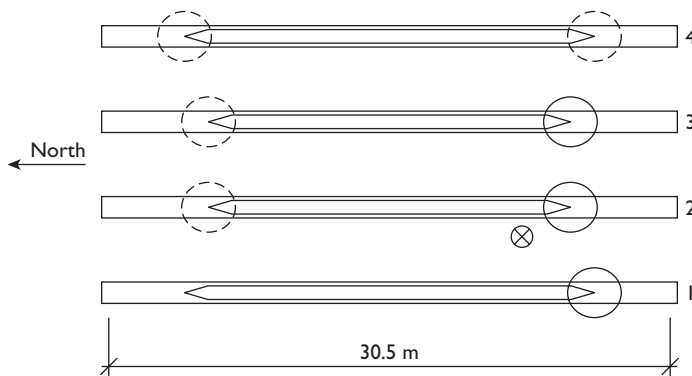
In three positions the crack was complete, i.e. had propagated across the entire depth of the girder (the south ends of girder No. 1, 2 and 3) and in four positions the crack had arrested in the web below the upper flange (the south end of girder No. 4, and the north ends of girder No. 2, 3 and 4) (Fig. 10.8).

Fig. 10.8 Complete fracture in the south ends of girder No. 1, 2 and 3, and partial fracture of the south end of girder No. 4 and of the north ends of girder No. 2, 3 and 4. For the sake of simplicity the flanges have been turned upside down – the flange widths have also been enlarged (in relation to the span length).

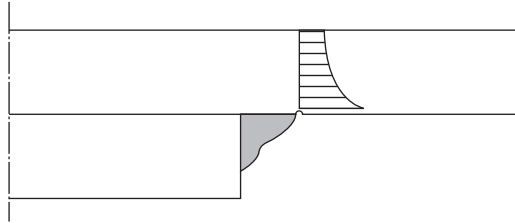
Fig. 10.10 Additional stress raising effects coming from the roughness of the surface, and, especially, melting ditches.

The roughness of the surface of the manual fillet weld, as well as melting ditches will increase this local stress raising effect even further (Fig. 10.10).

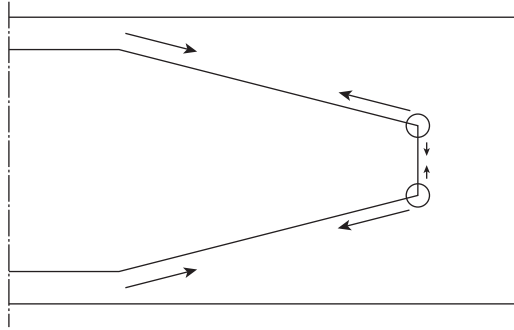
When the weld cools, and the contraction is restrained by the surrounding cold metal, small micro-cracks will form (as well as the forming of residual tensile stresses – counterbalanced by residual compressive stresses in the surrounding metal). One way of limiting the formation of these cracks (and the residual stresses) is to preheat the metal pieces to be joined; however, regions which still are especially prone to crack are corners, because of the combined effect of the start/stop-procedure of the welding and the restrained contraction thereafter during cooling (Fig. 10.11).

Fig. 10.11 The corner regions, where the probability for crack initiation is the highest. Here the combined effect of residual tensile stresses in the transverse and longitudinal direction is the highest.

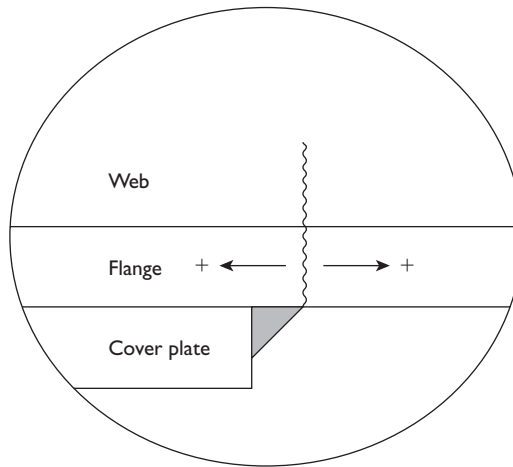
All these effects taken together make this region in the tension flange – at the cover plate end – very probable for the initiation and the following propagation of a *slow* fatigue crack (a small incremental increase in crack length for each new loading cycle) or a *fast* brittle fracture (the final failure starting from an existing crack for just one additional loading cycle). The crack will propagate *perpendicular* to the applied normal tensile stress, starting from the weld toe in the heat-affected zone (Fig. 10.12).

Fig. 10.12 A crack will initiate from the weld toe, in the heat-affected zone, and then propagate upwards into the web, perpendicular to the applied normal tensile stress.

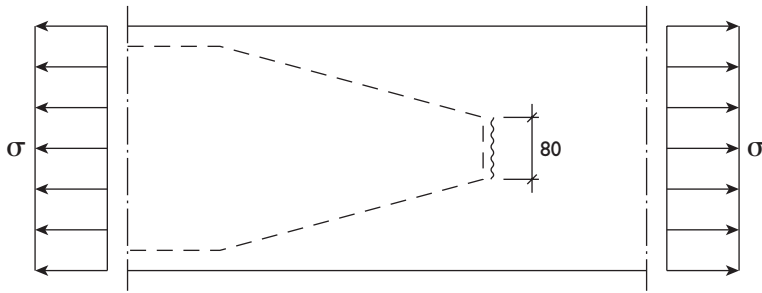
We assume a crack all along the length of the cover plate end (having a length equal to  $2a = 80$  mm) (Fig. 10.13).

Fig. 10.13 A centrally located crack all along the cover plate end.

The magnitude of this stress is so low that we can conclude – given the high allowable stress level – that the bridge was doomed to fail.

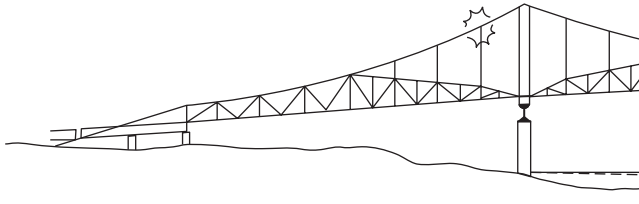
Fig. 11.7 The location of the fractured eye-bar chain joint.

Despite being unusual in design the bridge served its purpose well for almost 40 years, but on that fatal afternoon in December 1967 it was no longer capable of carrying the service load it was intended for. First the side-span on the Ohio side fell into the river, and then the main span and the other side-span followed almost instantaneously, and all cars on the bridge plunged down as well. After the first couple of days of chaos an investigation into the cause of the collapse commenced, where as many parts as possible of the bridge superstructure was salvaged from the river bed. A large number of probable causes were first considered (among them aerodynamic instability and sabotage), however, these were eliminated when a fractured eye-bar was found. The broken eye-bar was identified with respect to its original location, and it was found that it had been positioned in the second panel counting from the Ohio tower on the upstream north side, with its fractured end connected to the eye-bar in the first panel (Fig. 11.7).

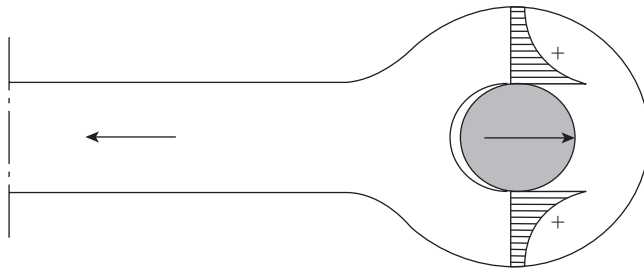
Fig. 11.9 Stress concentration effects in the eye-bar end.

to carry the gradual increase in loading (from 1928 to 1967) without exceeding the allowable stresses. However, it was soon realized that the actual loading of the eye-bar hangers was high, as they were made out of high-strength steel (the higher the strength the higher the allowable loading). For the eye-bar shank it was not a problem, however, the tensile stresses in the end parts – taking the stress concentration effects into account – were found to be very high (Fig. 11.9).

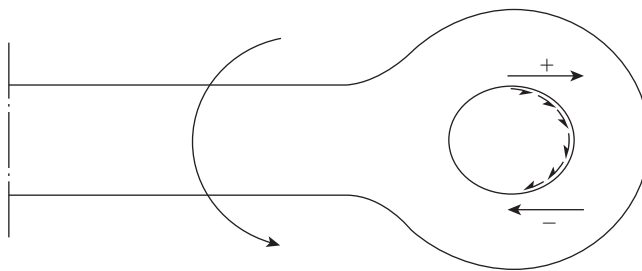
This rotation creates fretting due to the sliding friction between the pin and the hole edge, and at the ends of the contact zone it adds to the tensile stresses from the normal force, which drastically increases the probability of a fatigue crack being initiated at the surface (especially as the number of loading cycles equals that of the hanger). When the hanger is unloaded (with respect to the service load) the eye-bar chain elements rotate back, now creating sliding friction in the opposite direction (Figs. 11.11 and 11.12).

Fig. 11.11 Sliding friction between the pin and the hole edge as the eye-bar chain element is rotating back to its original position. Due to the restraint a partial fixed end moment is introduced.

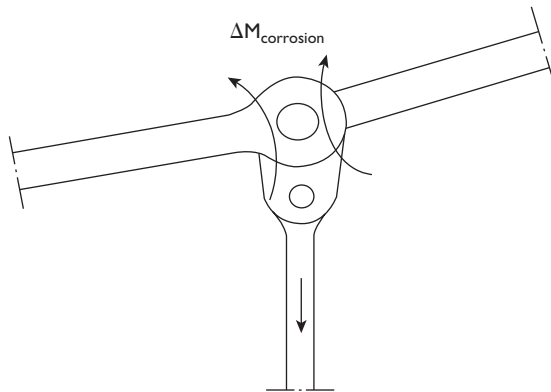
In an almost 40-year-old structure, where the maintenance was said to have been poor, there was also the possibility that adjacent eye-bar plate surfaces in the upper hanger joints (see also Fig. 11.8) had rusted stuck. If this was the case then rotation

of the eye-bar elements would have been prevented, introducing secondary bending stresses into the joint (as well as to the eye-bars) as soon as traffic load was carried by the hanger (Fig. 11.13).

Fig. 11.13 Secondary bending stresses are introduced if the joint has rusted stuck.

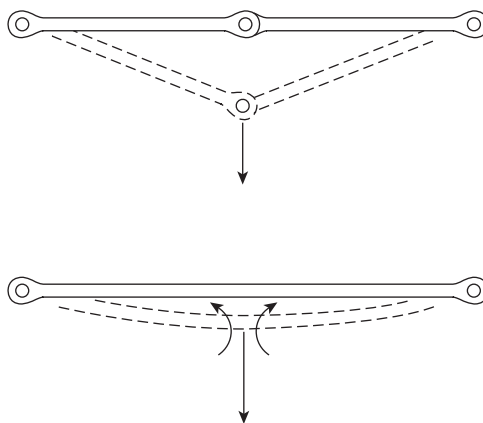
Fig. 11.14 The upper case where the eye-bar joint is free to rotate, and the lower extreme case where there is no rotational capacity at all, and therefore secondary bending stresses are being introduced.

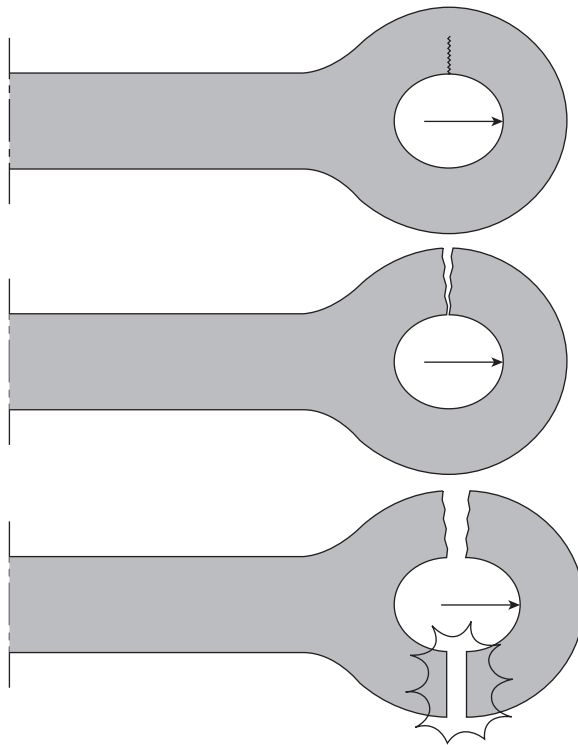
The most probable failure sequence was as follows; a fatigue crack in the upper portion of the eye-bar end (see Fig. 11.12) continued to grow upwards, perpendicular to the applied tensile stress (see Fig. 11.9), for each new loading cycle (of heavy vehicles passing the bridge) – gradually increasing the stress concentration effect (and hence the crack propagation rate) – until, finally, it reached a certain critical length and net-section (brittle) failure of the upper half occurred. The entire load was then carried by the lower portion, which deformed rapidly under the combined action of tension and bending, and broke more or less immediately in a brittle manner (Fig. 11.15).

As all the loading was then transferred to the remaining and intact eye-bar this had to carry twice the load as before, and above all, being now eccentrically loaded. It did not take that many additional loading cycles before it had worked itself free from the pin, resulting in the complete separation of the chain link, and the eventual collapse of the entire bridge. There were many other highly stressed locations though on the eye-bar chain link that could have preceded the failure of this particular member, but the combined effect of high repeated loading (not necessarily the highest), corrosion that both increased the sliding friction between hole edge and pin, and that prevented rotation of the joint that produced secondary bending stresses, and above all, the existence of a flaw in the material at the region where the stress concentration effect was the highest – the last parameter being the most important one in explaining why there is such a high uncertainty to pinpoint an exact crack location point. But then, the failure *had* to come at the north side of the bridge as only two out of three possible lanes were in use – the south side lane was transferred into a sidewalk, so the traffic

Fig. 11.15 A probable failure sequence.

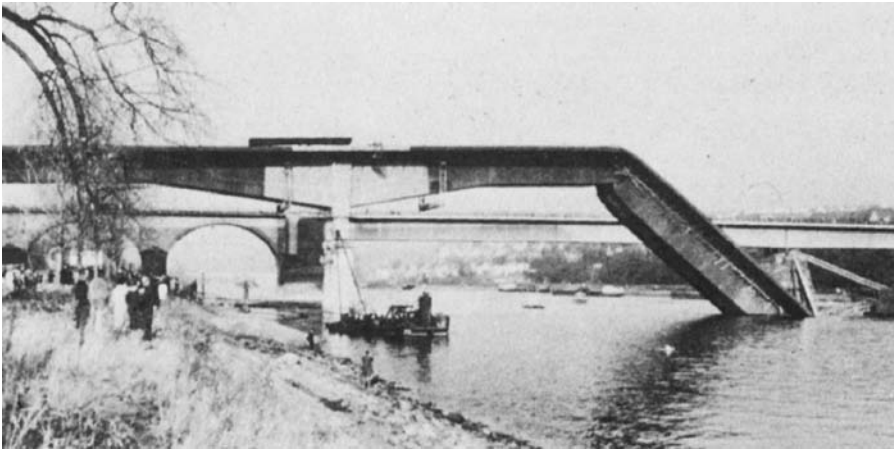
In order to minimize the obstruction to boat traffic, it was chosen to cantilever out the centre span from both directions (just as for the Danube Bridge). The cantilever arm was about 100 metres long, and it was only the erection of the final section remaining (an 18 metre high lift of a 16 metre long and 85 ton bridge element from the water level), as the cantilever arm collapsed approximately halfway out (Figs. 16.4 and 16.5).

The negative bending moment in the cantilever arm, because of the loading coming from from the self-weight of the girder, the weight of the crane, and the new girder element (plus the additional inertia forces as the cantilever arm must be assumed to have been set in swaying), created too much compression for the lower flange to carry, which buckled and transformed the statically determinate system into a mechanism.

Fig. 16.5 Photo taken just after the collapse (see also Fig. 16.4).

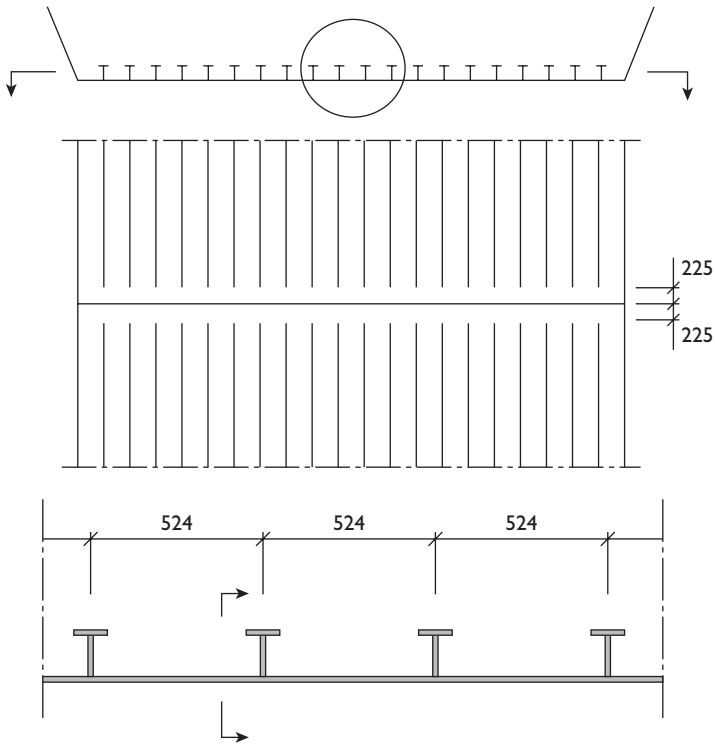
When two girder elements were to be joined together, there was a horizontal gap of 225 millimetres from each edge to allow for automatic welding in the transverse direction of the elements (without having to be interrupted by the many stiffeners) (Fig. 16.6).

Fig. 16.6 The longitudinal stiffener configuration of the box-girder bridge lower flange.

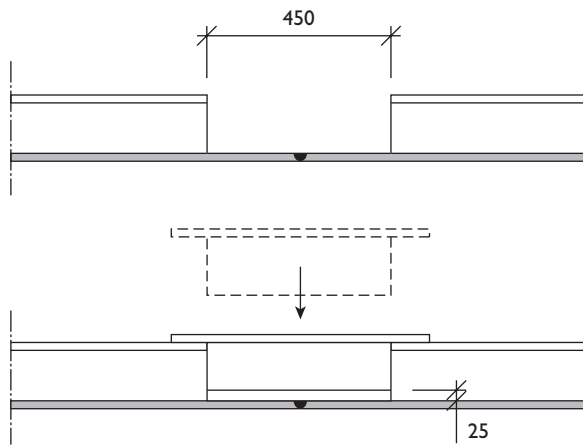
As the longitudinal stiffeners were to be made intact again (i.e. continuous over the joint), the choice was to “hang” a T-profile on to the edges of two adjacent stiffeners, instead of filling the gap with an exact profile. The intention was (and quite rightly so, looking at the problem from one point of view) to avoid crossing welds which is a weakening factor concerning fatigue and brittle fracture strength (Fig. 16.7).

This choice of configuration created a free vertical distance of 25 millimetre between the inserted profile and the flange plate, which unfortunately did show to be the direct reason why buckling was initiated. Almost the same type of splice had been used at the West Gate Bridge (see Fig. 15.11), however, not being the “triggering factor” for the collapse (as it did show to be here).

Fig. 16.7 The unfortunate choice of splicing longitudinal stiffeners.

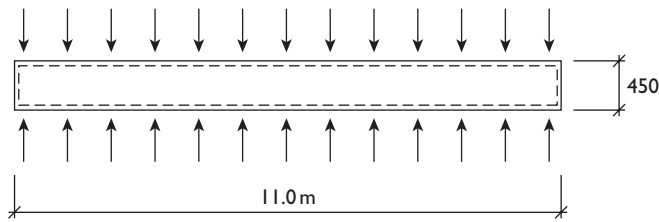
Fig. 16.8 The unstiffened part of the lower flange plate in between the longitudinal stiffener ends.

We will in the following study and analyze the load-carrying capacity of the lower flange plate in this more or less unstiffened zone. We lack information about the thickness of the plate and the yield strength of the steel material, however, as a qualified guess we assume  $t = 10$  mm and  $f_y = 360$  MPa. The flange plate is 11.0 metre wide and 450 millimetre long (in between the stiffener edges), and we assume simple supports along the four edges of the plate (Fig. 16.8).

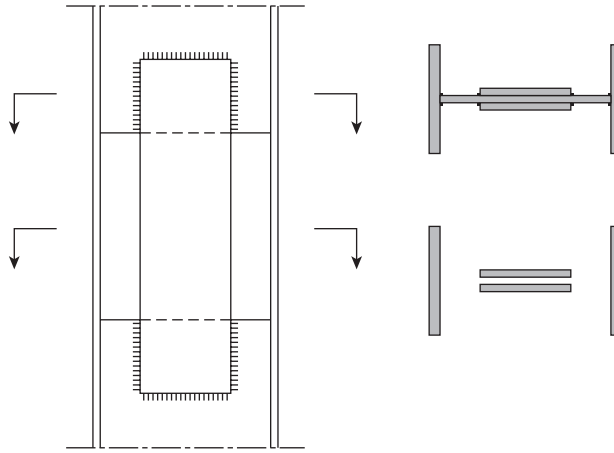
Fig. 16.9 A simplified model that could be used to explain and to understand the behaviour of the weak splicing of the longitudinal stiffeners in the box-girder bridge bottom flange – an axially loaded column having the web spliced with two cover plates over a free gap.

cross-section. As a similitude one can consider a column, that has a very special splice where the web is missing, and that the web has been replaced with two separate cover plates (Fig. 16.9).

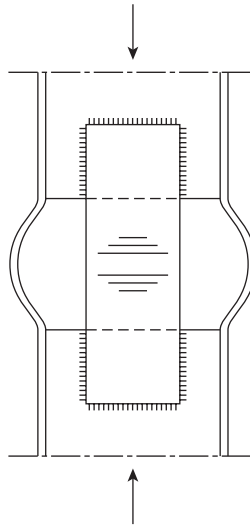
Fig. 16.10 Local buckling of the column having the web spliced.

For such a weak splice it is not difficult to imagine the scenario at the first heavy loading – the flange plate of the column, and the cover plates, will for sure buckle out (as the splice more or less also can be regarded as an initial hinge) (Fig. 16.10).

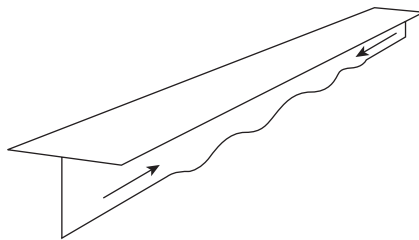
Fig. 16.12 The free and unstiffened lower edge of the inserted T-profile (in the gap) was a weak part with respect to normal stress buckling.

An additional effect, that also most certainly was not considered, was the weakness of the inserted T-profile, which had a an outstanding vertical part that was free and unsupported, and this made it prone for normal stress buckling along its lower edge (just as the case was for the free flange edge of the West Gate Bridge girder halves) (Fig. 16.12).

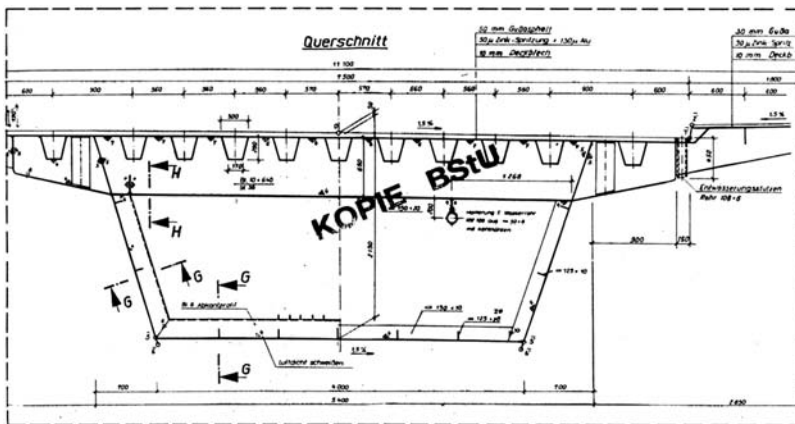
There was no exact and detailed explanation given in the *Stahlbau* article of the reason for the collapse, but still we will in the following give it a try to analyze the bridge cross-section to see if we can, somehow, prove that the bridge was inadequate in its design. The structural drawing, showing the cross-section of the box-girder, was the following (Fig. 17.6).

Fig. 17.6 Cross-section of the Zeulenroda Bridge, as given in the structural drawings. (Ekardt: Die Stauseebrücke Zeulenroda. Ein Schadensfall und seine Lehren für die Idee der Ingenieurverantwortung. Stahlbau. With kind permission of Karl-Eugen Kurrer)

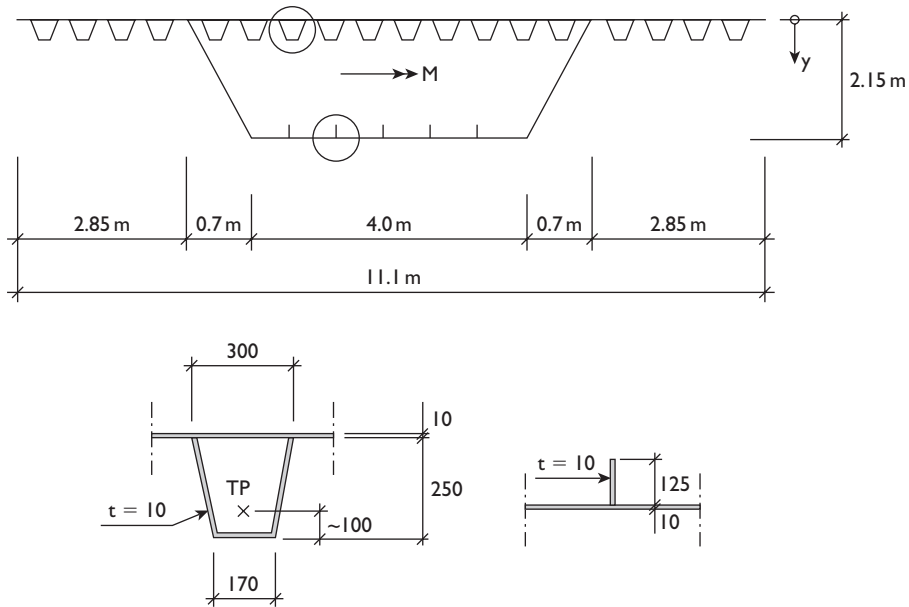
This drawing above gives us the information about the cross-section that we need for our analysis (Fig. 17.7).

Fig. 17.7 The cross-section used for the analysis to come in this text.

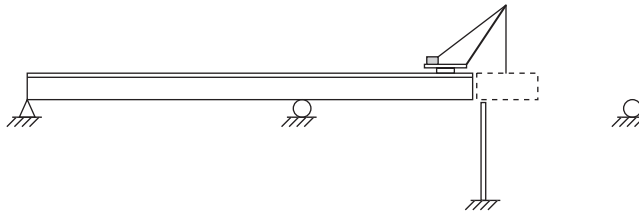
The assembly of the bridge was, as has been mentioned earlier, at the stage where the cantilever was halfway out, and that the next element was to be connected to the cantilever end, from then on also supported by a temporary support (Fig. 17.8).

Fig. 17.8 The next sequence in the assembly of the bridge (if it not had been for the collapse that is).

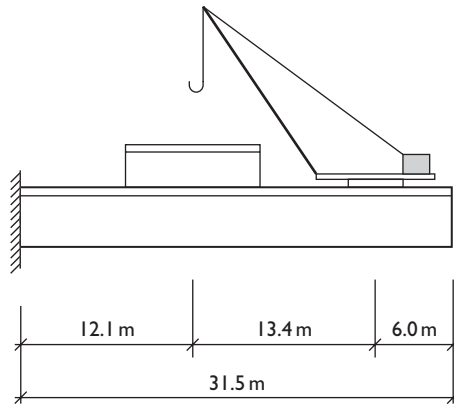
As the bridge gave way, the new element was not yet at the crane, instead it was positioned behind the same. The approximate positions of the crane and the element out on the cantilever were the following (Fig. 17.9).

Fig. 17.9 The positions of the crane and the new element just prior to the collapse (see also Fig. 17.5).

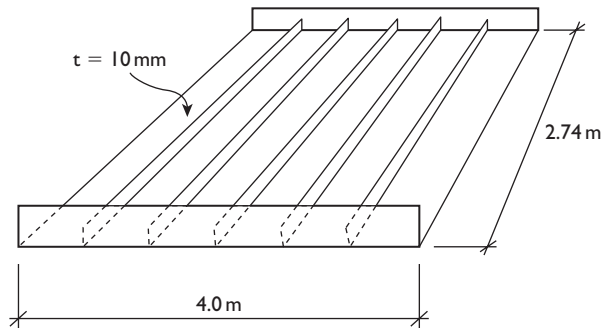
The lower flange, that shall carry a compressive stress of 212.5 MPa, is stiffened in the longitudinal direction by five flat steel bars and in the transverse direction by a stiffener each 2.74 metres (Fig. 17.11).

Fig. 17.11 Transverse and longitudinal stiffeners in the lower flange.

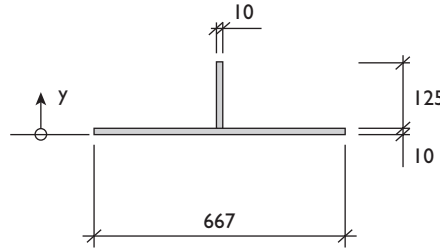
Fig. 17.13 Cross-section of the longitudinal stiffener and the interacting part of the lower flange plate.

We then have the following cross-section to analyze (Fig. 17.13).

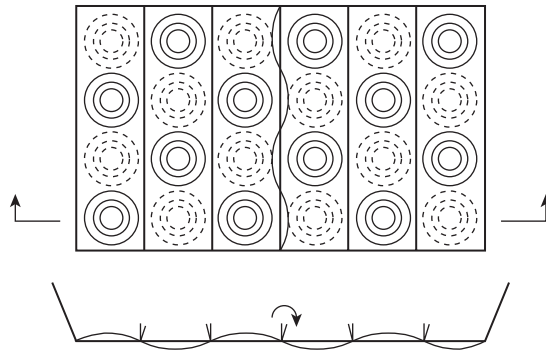
Fig. 17.14 The sine-wave buckling pattern in the flange plate has the effect on the longitudinal stiffeners that they tend to rotate in a sine-wave pattern as well.

From the results we see that the longitudinal stiffeners also were given too small dimensions, so the bridge was quite clearly doomed to fail during erection. And even if consideration is made regarding a more refined global buckling model – where for example the influence of the stiffening effect from the flange plate in the transverse direction is taken into consideration – there are more reducing effects that have to be considered which *lower* the load-carrying capacity. In order for a longitudinal stiffener to function as a rigid nodal point at buckling of the flange plate, it has not only to be sufficiently stiff in the out-of-plane direction (i.e. in the vertical direction relative the plane flange plate), but also be torsional stiff in order not to deform in the transverse direction due to the plate buckling (Fig. 17.14).

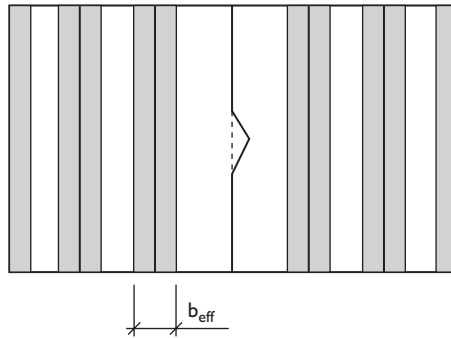
And if one longitudinal stiffener is eliminated, it also means that the total load-carrying capacity of the flange plate is reduced (as the effective width of the plate decreases) (Fig. 17.16).

Fig. 17.16 The negative effect on the overall ultimate load-carrying capacity of a stiffened plate because of a locally damaged stiffener.

Thus, the advice is never to choose flat bars as longitudinal stiffeners (as was done not only in the Zeulenroda Bridge, but also in the Fourth Danube Bridge, see Chapter 12) because of the above-mentioned reasons. Besides a negligible rotational (torsional)

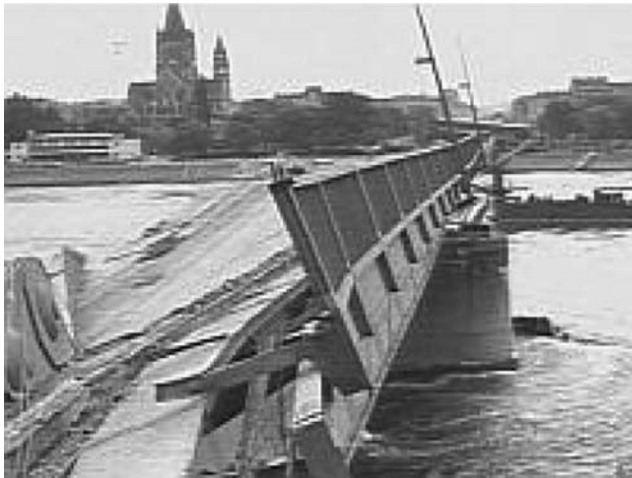
At first the authorities suspected a terrorist sabotage and had the other Danube bridges in Vienna guarded by police – a suspicion which is quite understandable as the collapse had occurred when there was more or less no traffic load on the bridge – but soon it became evident that the collapse had been initiated by the failure of the river pier (Fig. 18.6).

An expert commission was summoned to investigate the reason behind the collapse, and after a few months they presented their results. It was confirmed that the failure was due to the fracturing of the river pier, consisting of unreinforced concrete as it was. The effects of creep and shrinkage were also said to be contributing factors. The failure could not have been predicted the commission said. Knowing the fact though that the bridge piers were *unreinforced* indicates a long-term deterioration because of a gradual change of the inner stress state of the same. We will in the following consider a probable failure sequence.

Fig. 18.6 The end span supported by the collapsed river pier (to the bottom right in Fig. 18.5 above). ([www.reichsbruecke.net/geschichte\\_e.php](http://www.reichsbruecke.net/geschichte_e.php))

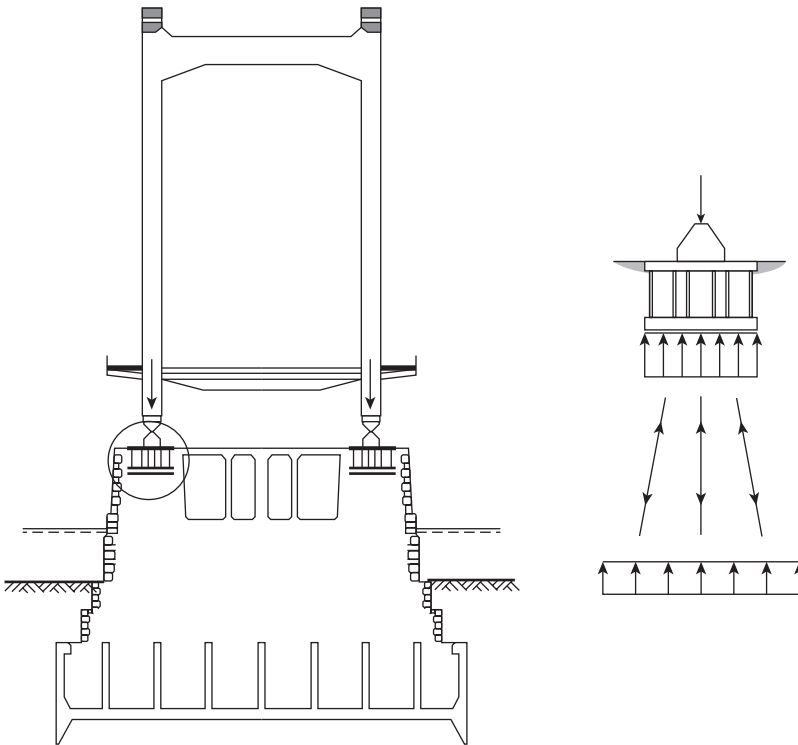
The vertical load from the bridge tower is distributed and dispersed into the pier (Fig. 18.7).

The inclined struts (especially the outer) have to be balanced in the lower part by a horizontal force (tie) which is introducing tension to concrete core. However, as the balancing force is small (at least at an initial stage) – due to the small inclination

Fig. 18.7 Cross-section and load distribution and dispersion under the tower foot. (Left-hand figure: first published by IABSE in Reiffenstuh, H.: Collapse of the Viennese Reichsbrücke: Causes and Lessons. IABSE Symposium, Washington 1982)

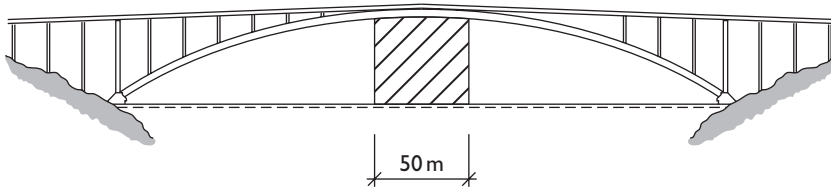
Fig. 19.6 With a sailing height of maximum allowed 41 metres the free sailing width was limited to 50 metres only.

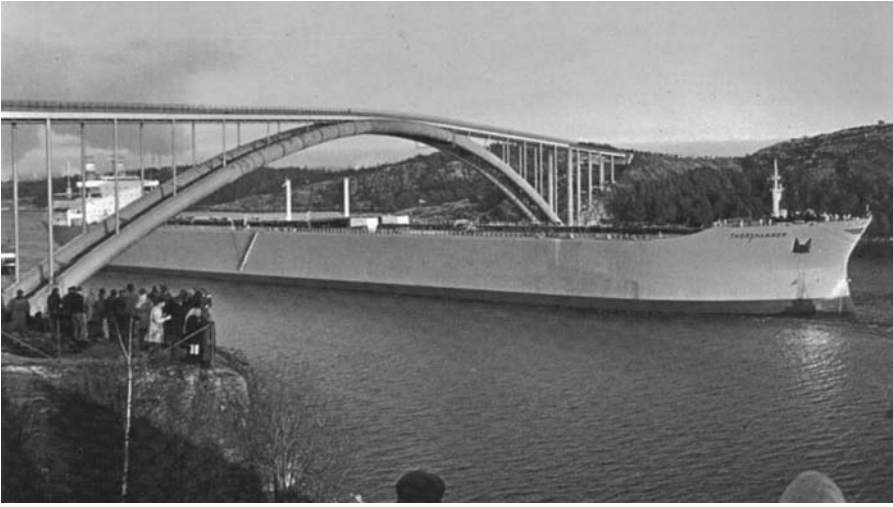
And every once in a while very large tankers, like the “Thorshammer” of 228,000 tons, were allowed to pass the bridge (guided by a pilot) (Fig. 19.7).

*Fig. 19.7* The passage of the giant tanker “Thorshammer” on 6 December 1969 – length 325 metres and width 48 metres. The clearance at the top was only 1.5 metres. Something like doing the Limbo Dance!

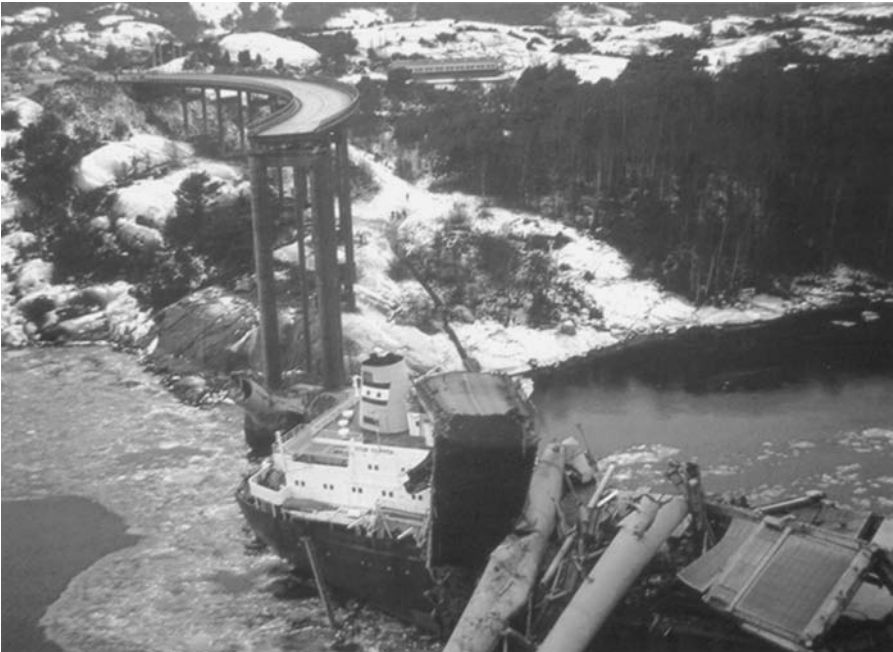
Uddevalla, hit the bridge only some 35 metres from the west abutment (i.e. on the Almö side) (Fig. 19.8).

To the despair of the ship's crew seven cars went over the edge before the traffic was stopped – the personnel tried in vain to warn the motorists by shooting signal rockets. Eight people died, and no one survived the fall into the water.

*Fig. 19.8* The collapse of the Almö Bridge. (Tjörnbron. The Swedish National Road Administration. With kind permission of Lennart Lindblad)

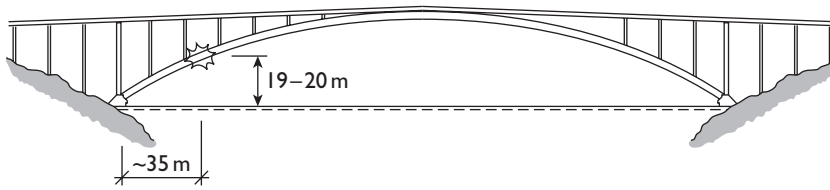
Fig. 19.9 The location where the bridge was hit by the Star Clipper gantry crane.

The ship hit the bridge tubes with its overhead gantry crane at a height of approximately 19–20 metres above the water level (some 35 metres from the shore) (Fig. 19.9).

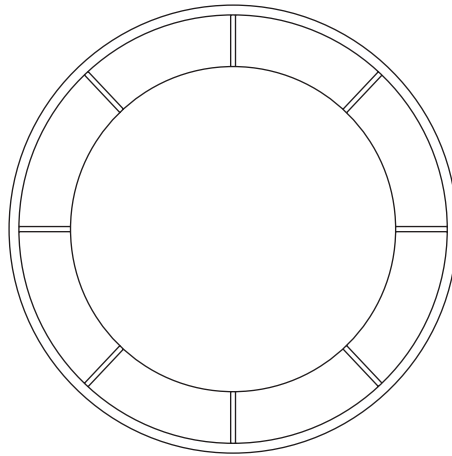
*Fig. 19.16* Longitudinal stiffeners in between the ring stiffeners would markedly have increased the stability of the membrane.

Perhaps it is somewhat rude to compare the Almö Bridge arch to a giant beer can, but then again it is inexcusable by the designer to *propose* and for the bridge owner/authorities to *accept* such a “collision-prone” structure, which, in addition, was so sensitive even to very small damages. The unstiffened cross-section (beside the ring stiffeners at the load-application points) was for sure too optimal for its own good. Would longitudinal stiffeners have been applied inside the tube then the load-carrying capacity would not only have increased but, most importantly, also the resistance to horizontal blows as well (Fig. 19.16).

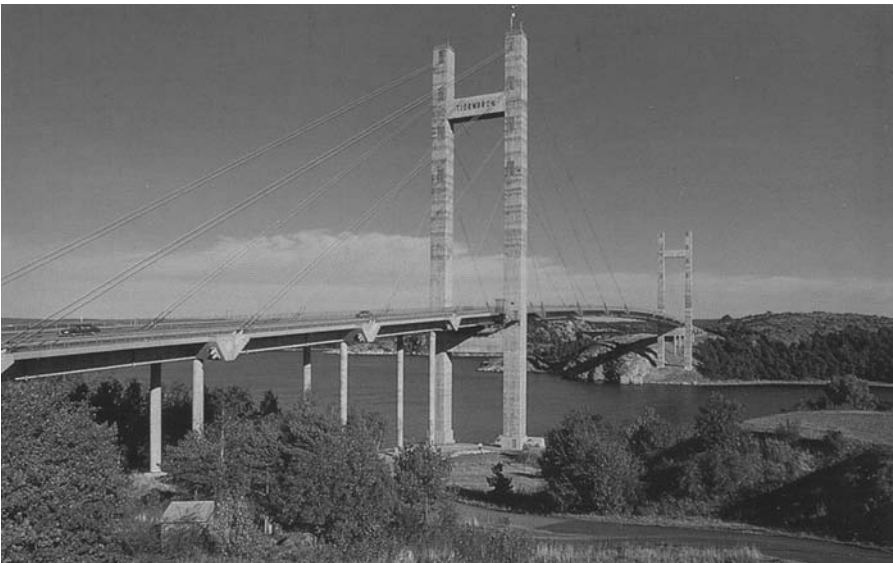
*Fig. 19.17* The new bridge between Almön and Källön, named the (New) Tjörn Bridge.

To accommodate for the transports to and fro the island of Tjörn a ferry was soon taken into service, and the planning of a new bridge was immediately started. Due to the intact approach ramps (see Fig. 19.8) – which could be used during construction (but not being part in the final bridge though) – and the fact that the project was given absolute priority from the authorities, the construction of the new bridge could begin already in August the same year. This time the choice fell upon a cable-stayed bridge with a main span of 366 metres, giving no restrictions whatsoever to the sailing width (Fig. 19.17).
