# Understanding Bridge Collapses

**Björn Åkesson**

*Consulting Engineer, Fagersta, Sweden*

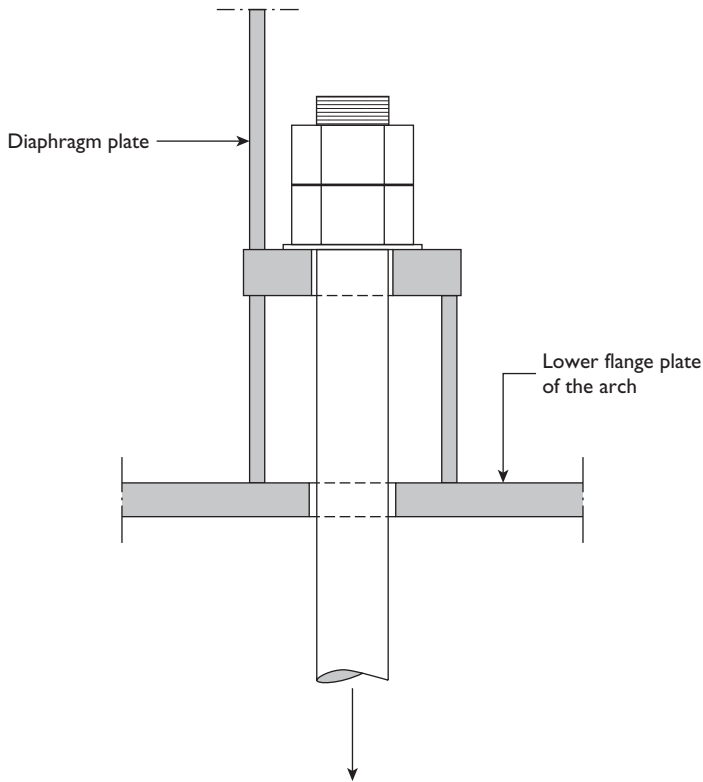
The last section of each hanger – close to the arch – was made up of a steel rod which was attached to the arch (inside the profile) by a connection detail (positioned at a diaphragm plate), where the rod was safely anchored by two nuts and a washer on the rod's threaded end (Fig. 20.7).

Fig. 20.7 Hanger-to-arch connection detail.

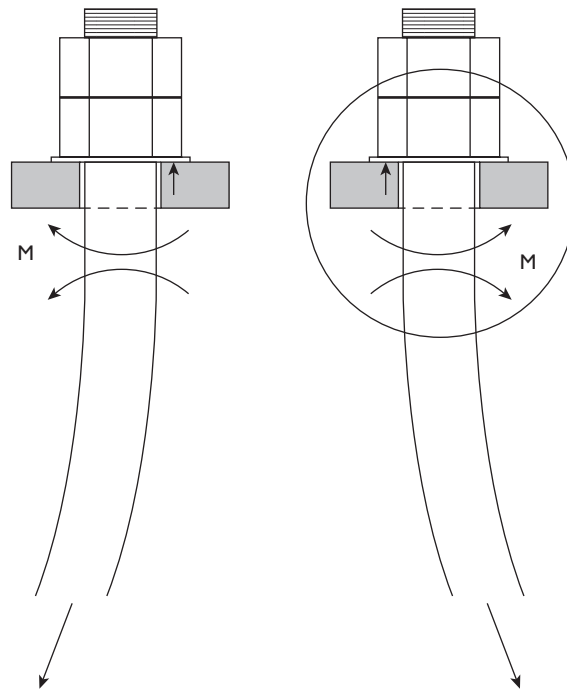
Fig. 20.10 Secondary bending of the hangers due to the inability of the pin joints to rotate.

to the arch, and as the hangers always were “vertical” there could not be any problem, could it? But, the inability of the pin joints to adjust to the rolling load on the bridge deck, led to back-and-forth bending deformations of the hangers (Fig. 20.10).

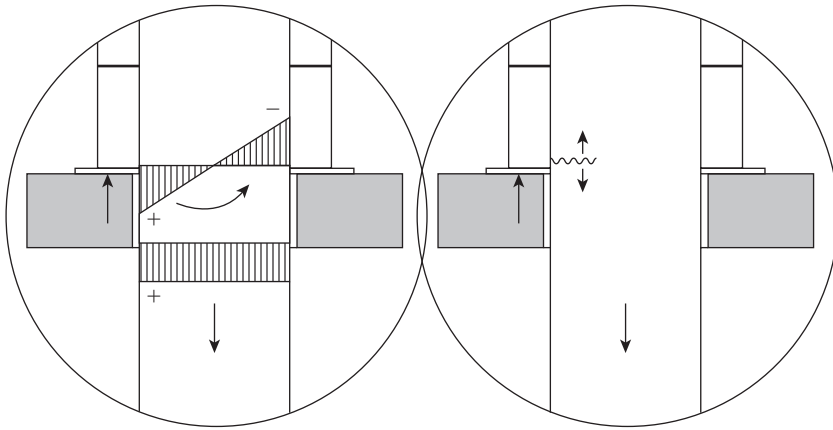
It is true that these secondary bending deformations (in the longitudinal direction) were very small, but over the long run (read: after a sufficient number of loading cycles, perhaps several millions) a fatigue crack was initiated in one of the hangers (Fig. 20.11).

Fig. 20.11 Secondary bending stresses, in addition to the normal tension stress, will eventually initiate a fatigue crack (see also Fig. 20.10).

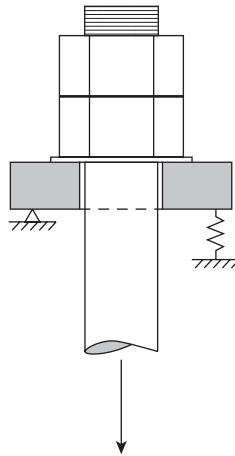
Fig. 20.12 The support conditions – a difference in stiffness due to the single diaphragm plate (see also Fig. 20.7).

It was the hanger closest to the abutment of the northwest corner of the bridge that failed first, being the shortest (i.e. more axial stiff than the rest of the hangers), thus experiencing more dynamic effects than the longer and softer hangers. The rolling load coming from north (or south for that matter) will also produce a more type of “shock loading” to the first hanger than the ones more centrally located in the bridge where the load is more evenly distributed and transferred in a more gradual manner. In addition to these dynamic effects, there was also a small defect present in the threaded part of the rod where the crack had originated from. Most likely the difference in stiffness of the support plate “bearings” also contributed to the initiation of the crack, probably then starting from the stiffer side at the diaphragm plate (Fig. 20.12).

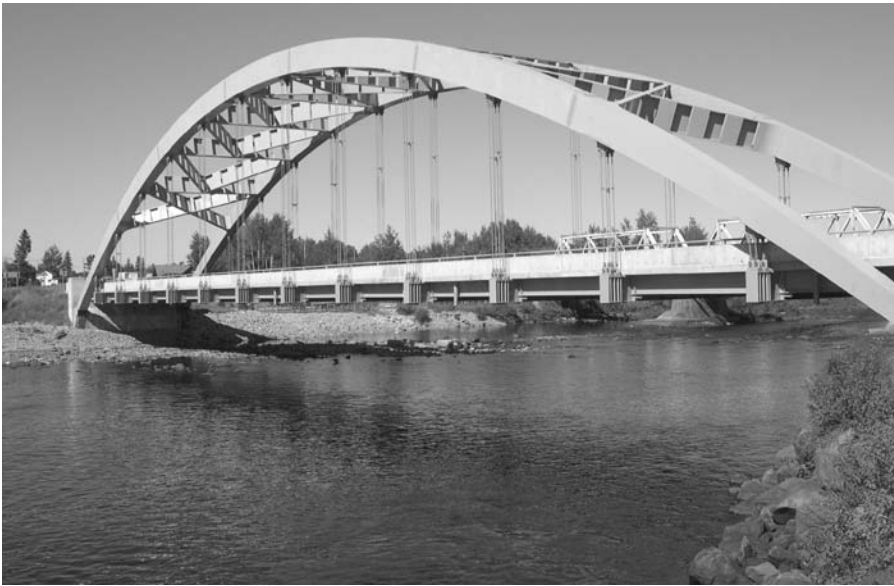
Fig. 20.17 The rehabilitated Aubrey Cosens Bridge at Latchford, September 2007 (with kind permission of Cameron Bevers, photographer and copyright holder).

The Aubrey Cosens Bridge was eventually repaired and again taken into service in 2005, this time using four cable wires in each hanger location instead of a bending stiff rod (Fig. 20.17). The use of several parallel cables (instead of a single thick one) is also a good choice with respect to safety and robustness – the loss of one wire would not mean the entire failure of the hanger as the remaining wires would take over the load.

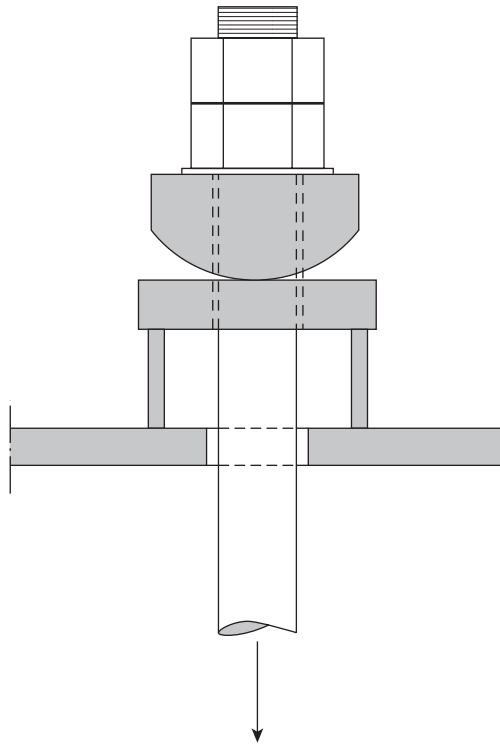
Fig. 20.18 A rocker bearing as an alternative design.

As an alternative to the connection detail at the top to the arch in the *old* bridge – as it was originally designed – the use of a *rocker bearing* (a true one) would most probably have saved not only the Aubrey Cosens Bridge, but also the Kufors Bridge. However, if the pin joints of the hangers would have been properly inspected and maintained then a rocker bearing solution is superfluous. But as a safeguard to any hidden friction problems, the upper pin joint – of the original design – could be omitted and a rocker bearing at the top be used instead, as a safe life solution (Fig. 20.18).
